Release Date	10/24/2023	Technical Service Bulletin		
97HJ UPDATE

Audi
Retrofitting Cable Holder – (NVLW)

This Update has been proactively released to prevent the following condition(s) from occurring in the vehicle:	
Criteria	Technical Background
01	On Audi e-tron GT vehicles manufactured within a specific period, the movement of the wiring harness in the area of the rear lid hinge may be restricted.

Criteria	Remedy
01	The cable routing will be modified on the affected vehicles and an additional cable holder will be added.

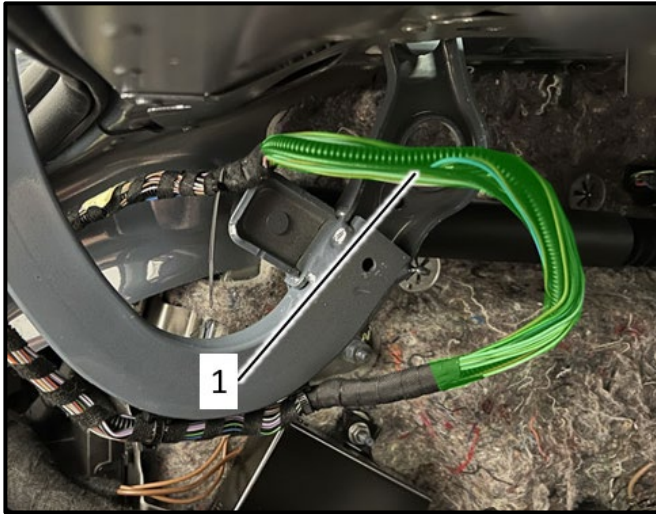
- Inspect the harness <1> in the highlighted area for any damaged wires and/or cables.
- If any damage is found, repair the wires and/or cables according to the ELSA repair manual:
 - For wiring repairs: *Repair manual > Electrical system > General information – Electrical Equipment > 97 Wiring > Wiring > Wiring Harnesses, Repairing.*
 - For Coaxial cable repairs: *Repair manual > Electrical system > General information – Electrical Equipment > 97 Wiring > Wiring > Antenna wires, Repairing.*

Document the length of wire and the number of connectors used in the repair order comments.
