Technical product information

Topic	New Continental GT 48V anti-roll bar cable routing
Market area	Australia E04 Bentley rest Asia and Australia (6E04),China 723 Volkswagen (Anhui) Automotive CO (6723),China 796 VW Import Comp. Ltd (Vico), Beijing (6796),Germany E02 Bentley rest Europe (6E02),Japan E03 Bentley Japan (6E03),Korea, (South) E08 Bentley South Korea (6E08),United Arab Emirates E06 Bentley Middle East and Africa (6E06),United Kingdom E01 Bentley UK (6E01),United States E05 Bentley USA and rest America (6E05)
Brand	Bentley
Transaction No.	2051712/8
Level	EH
Status	Released for publishing
Release date	26-Sep-2023

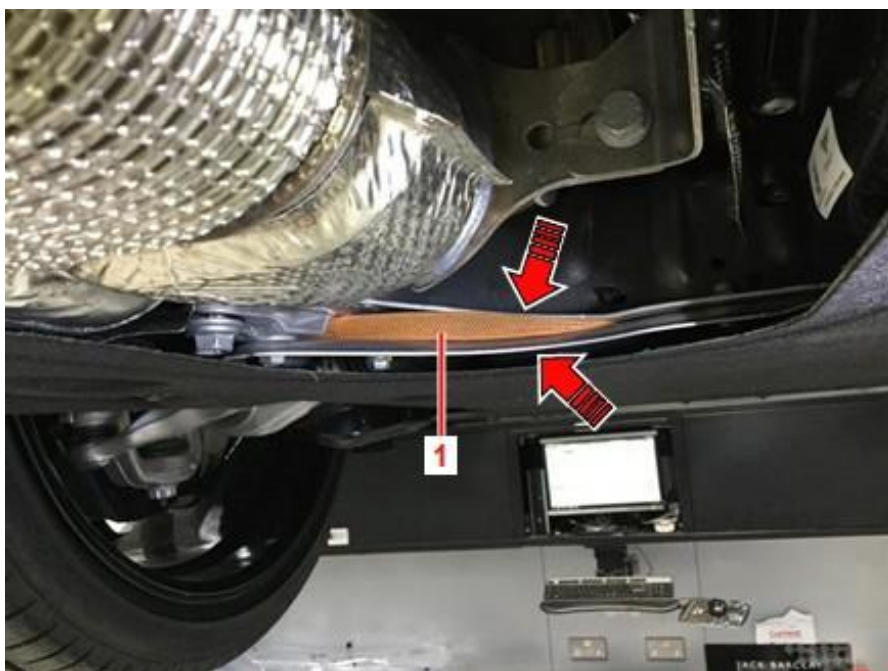
Figure 1

The 48 volt electrical supply cable looks as if it is trapped between the cross brace and transmission heat shield but is the correct condition.

The 48 volt supply cable (1) to the anti-roll bar may appear to be trapped between the front subframe and the engine undersheet (**arrows**). See Figure 1.

This would be visible on the LH underside of the vehicle and is the **normal** condition for this routing of cable.

Do **NOT** raise a DISS technical query for this concern.
