Technical product information

Topic	New Continental GT - Ski hatch difficult to latch/unlatch
Market area	Australia E04 Bentley rest Asia and Australia (6E04),China 723 Volkswagen (Anhui) Automotive CO (6723),China 796 VW Import Comp. Ltd (Vico), Beijing (6796),Germany E02 Bentley rest Europe (6E02),Japan E03 Bentley Japan (6E03),Korea, (South) E08 Bentley South Korea (6E08),United Arab Emirates E06 Bentley Middle East and Africa (6E06),United Kingdom E01 Bentley UK (6E01),United States E05 Bentley USA and rest America (6E05)
Brand	Bentley
Transaction No.	2052208/7
Level	EH
Status	Released for publishing
Release date	03-Oct-2023

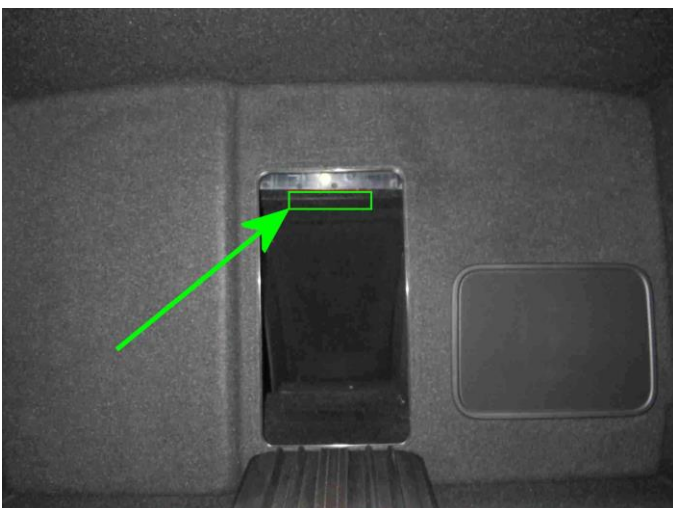
Figure 1

Due to tight tolerances the ski hatch mechanism fouls the upper ski hatch trim when closed/locked.

- Refer to Figure 1, looking into the boot locate the ski hatch lock aperture which is in the area shown

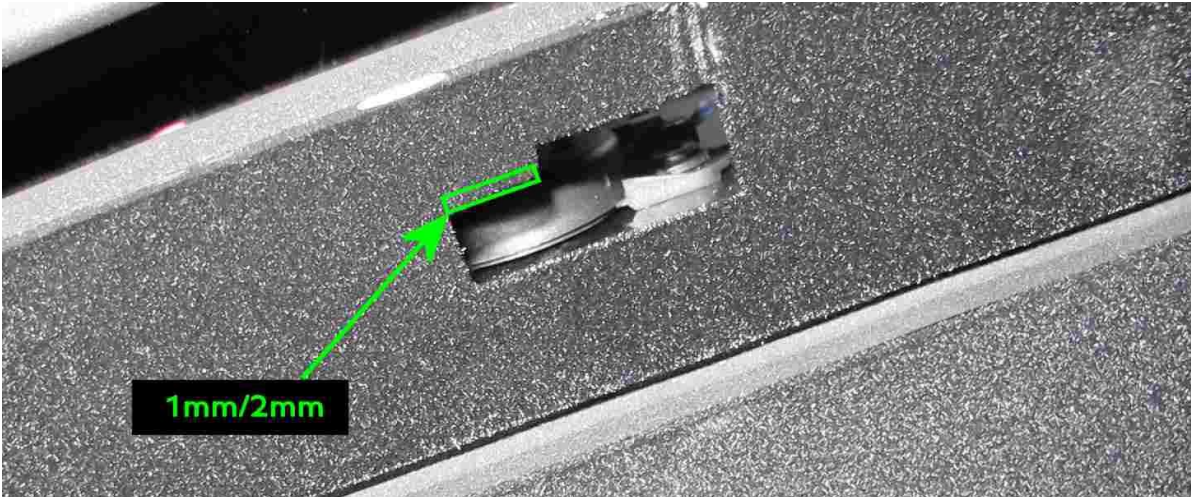
Figure 2

The close proximity of the mechanism in relation to the hatch trim when closed/locked can create difficulty in opening/unlocking the hatch

- Referring to Figure 2, Using a suitable tool initially remove up to 1mm from the trim and retest
- In the event the hatch does not close remove a further 1mm from the lock trim and retest
