## Technical product information

| Topic | New Continental GT and GTC - Rattle / Buzzing Noise - Head-Up display |
| Transaction No. | 2052431/9 |
| Release date | 26-Sep-2023 |

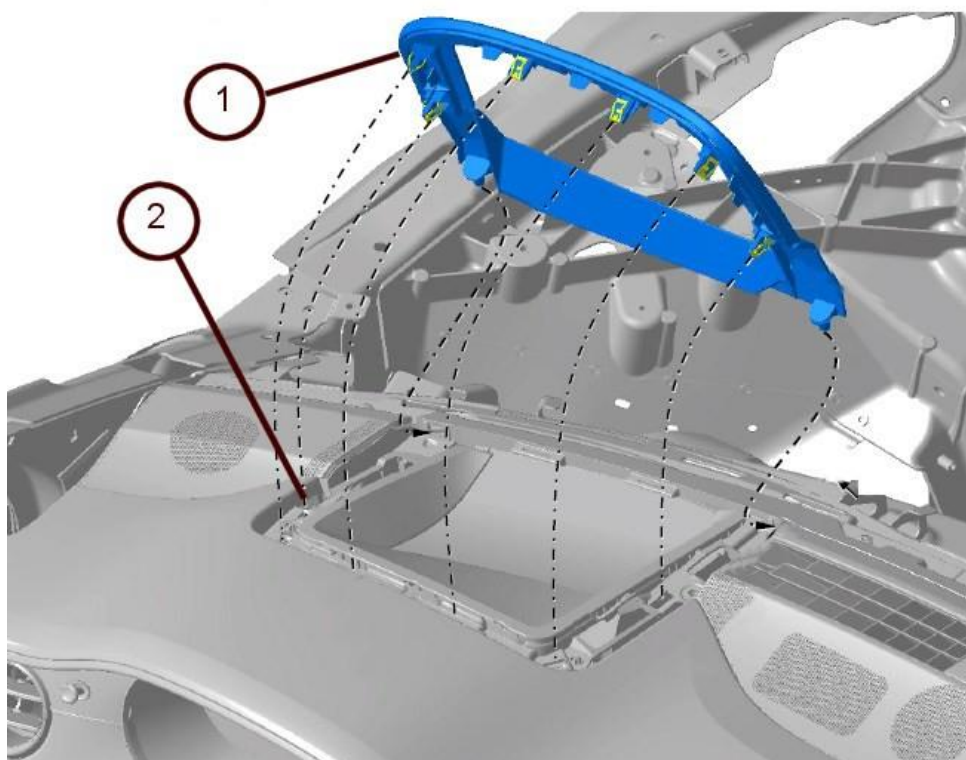
- Relative movement between Control Unit for Head-Up Display and associated Trim Ring – Figure 1
- Contact between the dashboard and dashboard upper trim panel.
- Head-up Display internal fault

1 – Trim Ring

2 – Control Unit for Head-Up Display

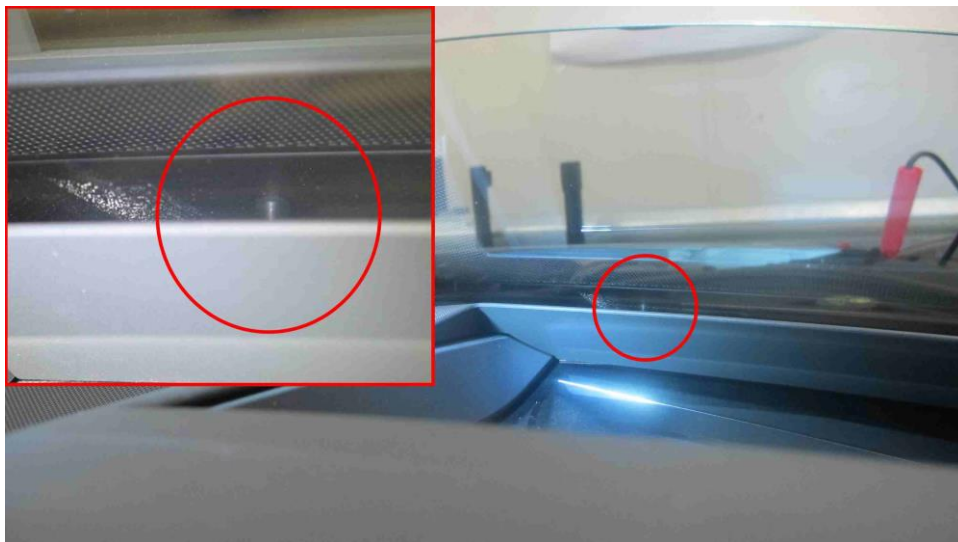
Figure 2

Bump stop introduced to the dashboard at the forward area of the HUD – Figure 2.
