## Technical product information

<b>Topic</b>	Unable to run basic settings within the Adaptive suspension control unit (J775)
<b>Market area</b>	Australia E04 Bentley rest Asia and Australia (6E04),China 723 Volkswagen (Anhui) Automotive CO (6723),China 796 VW Import Comp. Ltd (Vico), Beijing (6796),Germany E02 Bentley rest Europe (6E02),Japan E03 Bentley Japan (6E03),Korea, (South) E08 Bentley South Korea (6E08),United Arab Emirates E06 Bentley Middle East and Africa (6E06),United Kingdom E01 Bentley UK (6E01),United States E05 Bentley USA and rest America (6E05)
<b>Brand</b>	Bentley
<b>Transaction No.</b>	2055693/4
<b>Level</b>	EH
<b>Status</b>	Released for publishing
<b>Release date</b>	26-Sep-2023

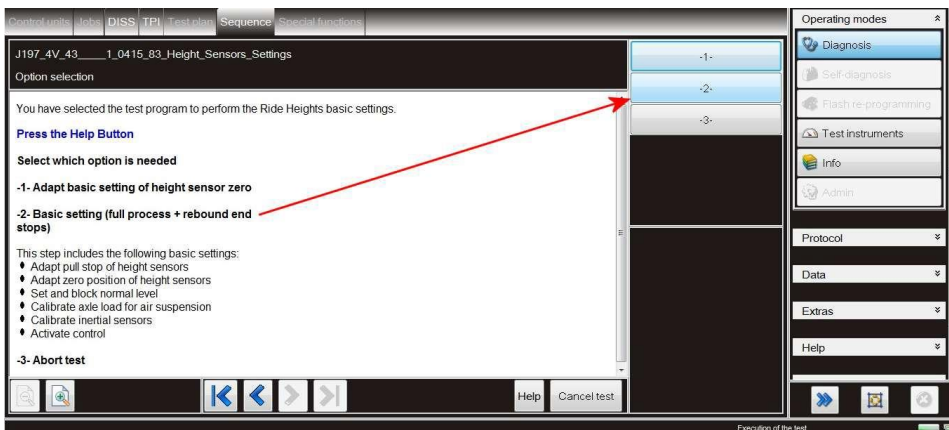
Figure 1

Referring to Figure 1, During the Basic setting (full process + rebound end stops) the routine can stop during the initial part of the procedure, in particular at the stage shown in Figure 2, which is when the vehicle is raised to allow all four wheels to hang down to their full rebound position

Should this issue be evident and the Basic settings routine does not continue - Refer to the Measure section of this TPI

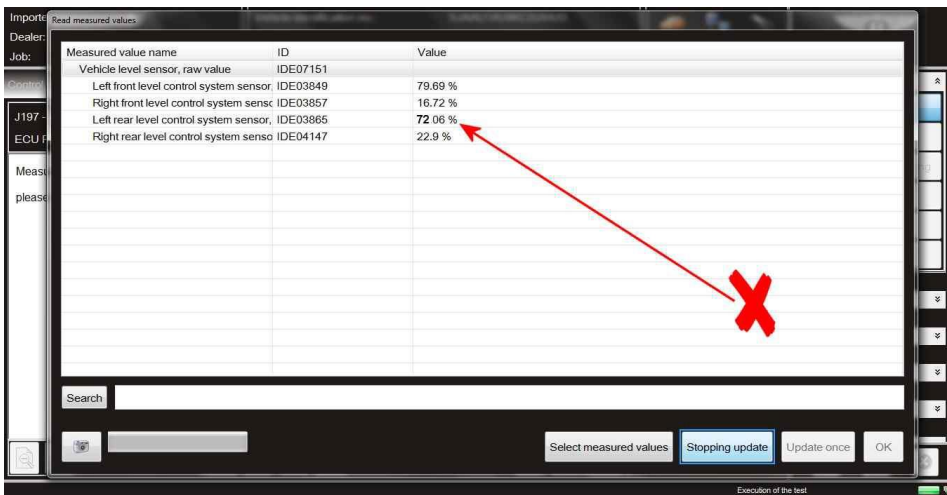
- Compare the sensor measured results in Figure 4 against the correct tolerance bands shown in Figure 5
- Within the example shown, the left hand rear level control sensor is not in tolerance as the value is **72.06%**

- When IDE 07151 is located - Select - Starting update
  - Monitor the measured value results for each level control sensor (Figure 4)

- 3) To allow the Basic setting (full process + rebound end stops) to be successfully completed the measured value results must all be within the tolerance bands shown in Figure 5

- Manually adjust the out of range level sensor by moving the sensor connecting arm whilst monitoring the values until the value falls within the specified tolerance band

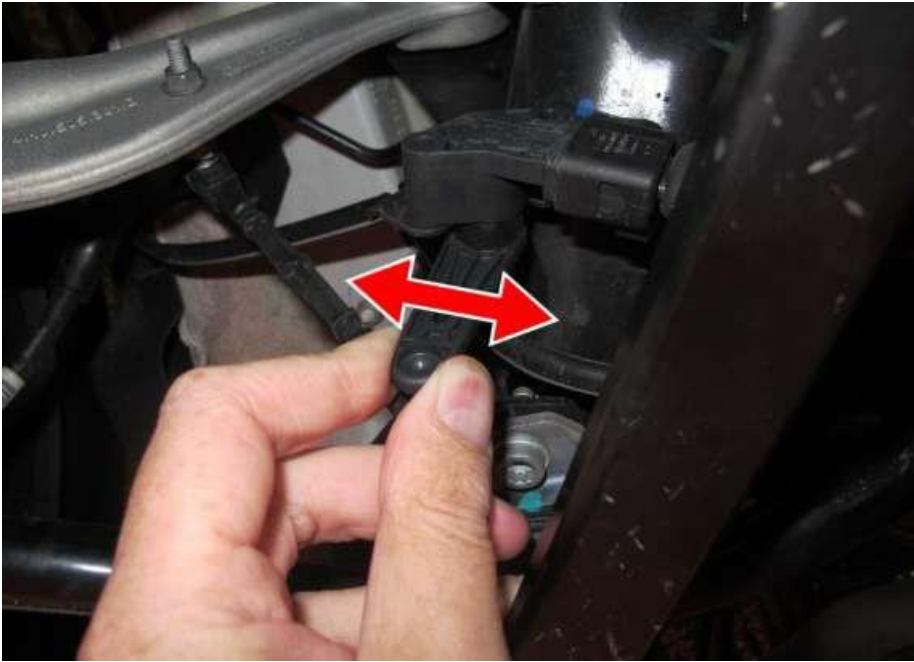
Figure 6

**NOTE: For photographic purposes only the left hand rear sensor is shown in Figure 6**

Referring to Figure 6, The correct tolerance should be achieved by moving the sensor arm (by hand within the parts natural limits of movement) in the required direction until the tolerance band is within specification NOTE: The tolerance can be achieved by using the recommended method

**⚠ DO NOT ATTEMPT TO ADJUST THE TOLERANCE BAND OF THE LEVEL SENSORS BY PRYING, BENDING OR MANIPULATING THE SENSOR RODS BY THE USE OF FORCE**

- Once the required tolerance band criteria is met carry out the Basic setting (full process + rebound end stops) until completion
