Excessive Resistance of Door Side Windows When Being Raised/Lowered, Cracking and/or Squeaking Noises

Topic number	LI72.00-P-072603
Version	4
Function group	72.00 - General
Date	10/24/23
Validity	MODEL 167 as of production date: September 2019 to production date: All 167 front doors at left and right: April 22 2021 MODEL 167.1 rear doors at left and right: May 25 2021 MODEL 167.3 rear doors at left and right: June 4 2021 MODEL 167.9 rear doors at left and right: June 16 2021
Reason for change	Note "Repair package available" in "Operation number/damage code" tab added

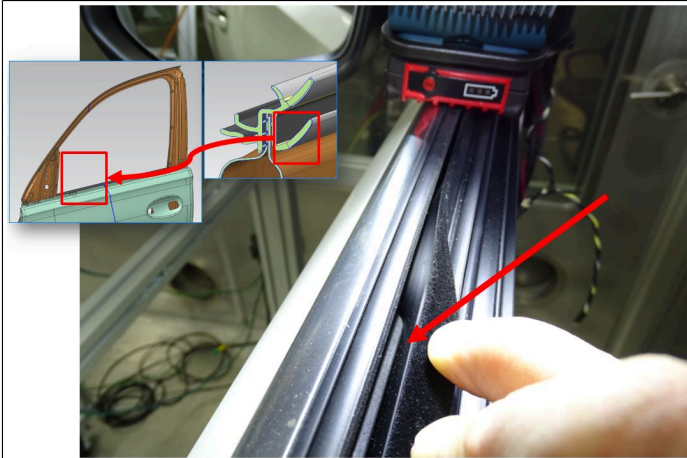
Attachments	
File	Description
Bild 1.JPG

Sealing lip of inner sealing rail, see Picture 1 and Picture 2, pos. 90, folds down while side windows are being lowered (opened).

When the side windows are raised (closed), the sealing lip is pulled back up again.

1. Make a video of the problem of the inside of the door in the area of the inner sealing rail, and pull the upper lip of the inner sealing rail to one side while doing so and check to see if the lower lip is folded over, for example, see picture 1.
2. Details on environmental conditions in a problem case (temperature, dry or wet)
3. Pictures of inner sealing rail when removed:
 - Both mounting face lips towards the glass
 - Any visible damage on the inner sealing rail

Replace inner sealing rail.

Then perform normalization of the window lifter system in the relevant door control unit.

For this complaint, no other surrounding component parts, such as outer sealing rails, Picture 1 and Picture 2, pos. 70, window lifter components or door control units, must be replaced or flashed.
