Technical product information

Topic	Infotainment screen turns red sporadically
Market area	Australia E04 Bentley rest Asia and Australia (6E04),China 723 Volkswagen (Anhui) Automotive CO (6723),China 796 VW Import Comp. Ltd (Vico), Beijing (6796),Germany E02 Bentley rest Europe (6E02),Japan E03 Bentley Japan (6E03),Korea, (South) E08 Bentley South Korea (6E08),United Arab Emirates E06 Bentley Middle East and Africa (6E06),United Kingdom E01 Bentley UK (6E01),United States E05 Bentley USA and rest America (6E05)
Brand	Bentley
Transaction No.	2055846/8
Level	EH
Status	Released for publishing
Release date	28-Sep-2023

New Continental GT and New Continental GTC

New Flying Spur

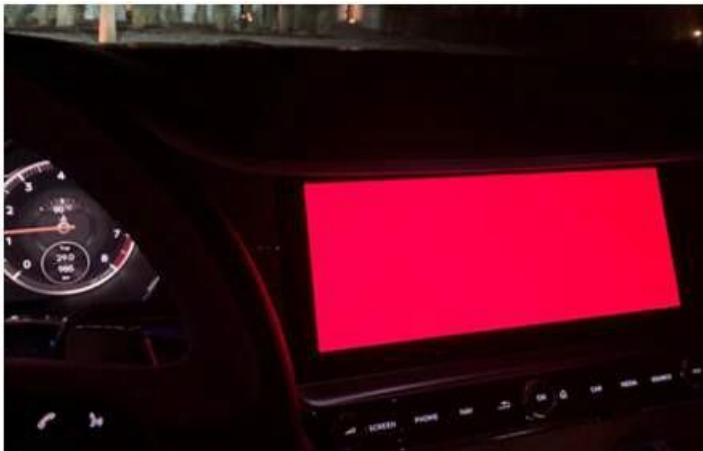
Figure 1

Infotainment screen 'Goes Red Fully or partially' within the MMI Screen (Figure 1)

The operative should complete the questionnaire within the Measure section of this TPI, once completed the questionnaire should be attached to an existing or already open DISS query the operative should await feedback before conducting any further work
