Rosenbauer America Technical Service Bulletin TSB23009

Subject: 20-amp shoreline connector

Form ID: WI23014

Removing the Engine Block Heater Wiring Extension

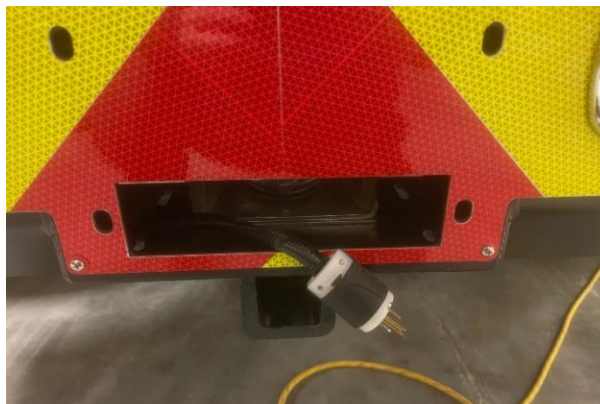
Fig. 1 Block heater with male cord plug installed.

- Cut the engine block heater wiring from the 120-volt wiring connection located under L1 compartment, near Auto-Eject
 - The wire end that was removed needs to be sealed and secured with zip ties.
- Cut the engine block heater wiring from the 120-volt wiring connection located under the front bumper.
 - The wire end that was removed needs to be sealed and secured with zip ties.
- Feed the engine block heater wiring through the front bumper and install the male cord plug on the end of the engine block heater wiring that's hanging out of the bumper (see Fig. 1).
