Service Alert

CONNECTED VEHICLE SYMPTOM TROUBLESHOOTING

Service Alert No.: SA-009/23

Last Issued: 10/23/2023

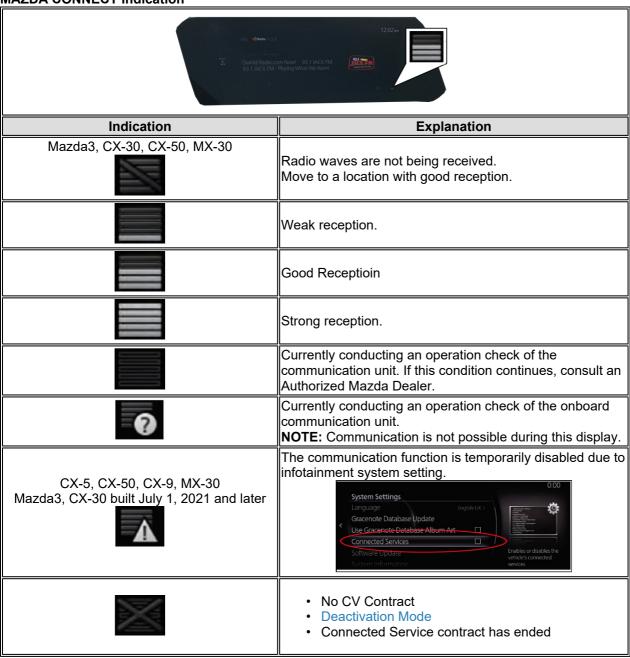
MAZDA CONNECT Indication

- 1. Infotainment Center Display does not provide the Authorization Code (OTP) during the MyMazda App Connected Vehicle enrollment.
- 2. Remote function(s) inoperative.
 - Engine Start / Stop
 - Door Lock / Unlock
 - Lights ON / OFF
- 3. MAZDA CONNECT connected vehicle reception strength icon shows "X" or "\".

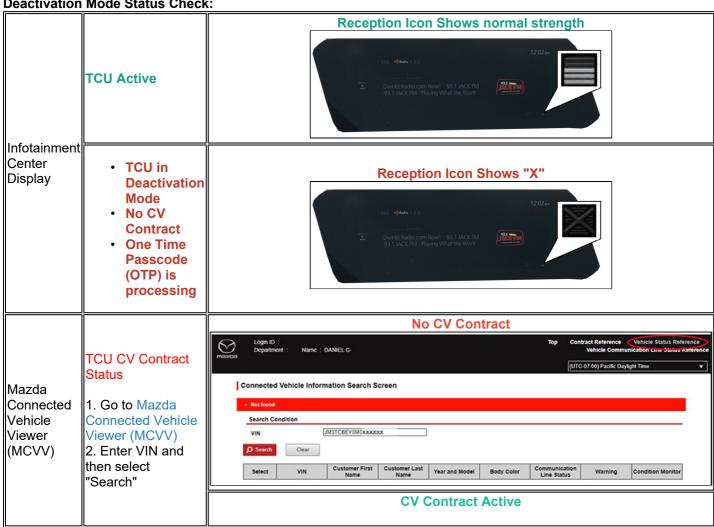
Deactivation Mode Status Check:

- Deactivation Mode Temporary Suspension 6/16/2023 (6/11/2023 retail date and later)
- Vehicles retailed before 6/11/2023 and in Deactivation Mode will remain in Deactivation mode.

- Customer/Dealer can activate CV services anytime via MyMazda app
 - Customer There might be a slight delay in making the backend connection since it was temporarily deactivated.
 - Dealer Go to Repair Procedure -> TCU Activation
- When TCU is in Deactivation Mode, infotainment Over-the-Air (OTA) Connectivity Master Unit (CMU) software update is not possible (disabled).
- Prior to Retail Date, the TCU is active.
