Service Alert

Mazda North American Operations
Irvine, CA 92618-2922

Subject: ELECTRICAL CONCERN AND/OR MULTIPLE DTC'S DUE TO AFTERMARKET DEVICE	Service Alert No.: SA-032/23
	Last Issued : 10/11/2023

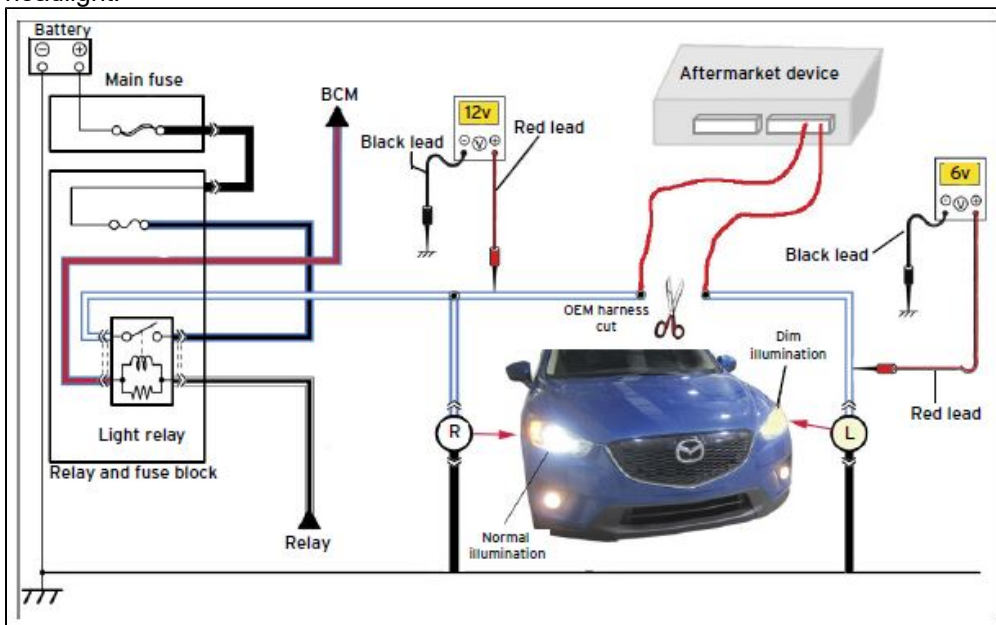
Below is an example of a dim headlight. The aftermarket device changed the headlight circuit resistance, causing a dim headlight.

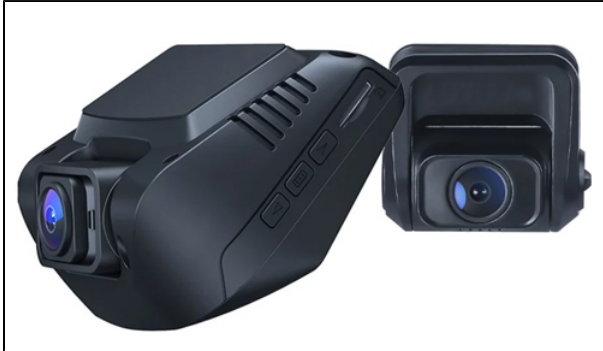
DTC B119F:01 (TEL antenna No.1 malfunction) stored. This may be caused by an aftermarket dash cam, **radar detector and/or FasTrak device.**

The aftermarket device may cause electrical noise disturbing the reception of GPS signals.
