Technical product information

Topic	Convertible hood cannot close - Header trim flap eyelet broken
Market area	Australia E04 Bentley rest Asia and Australia (6E04),China 723 Volkswagen (Anhui) Automotive CO (6723),China 796 VW Import Comp. Ltd (Vico), Beijing (6796),Germany E02 Bentley rest Europe (6E02),Japan E03 Bentley Japan (6E03),Korea, (South) E08 Bentley South Korea (6E08),United Arab Emirates E06 Bentley Middle East and Africa (6E06),United Kingdom E01 Bentley UK (6E01),United States E05 Bentley USA and rest America (6E05)
Brand	Bentley
Transaction No.	2060120/7
Level	EH
Status	Released for publishing
Release date	03-Oct-2023

New Continental GTC

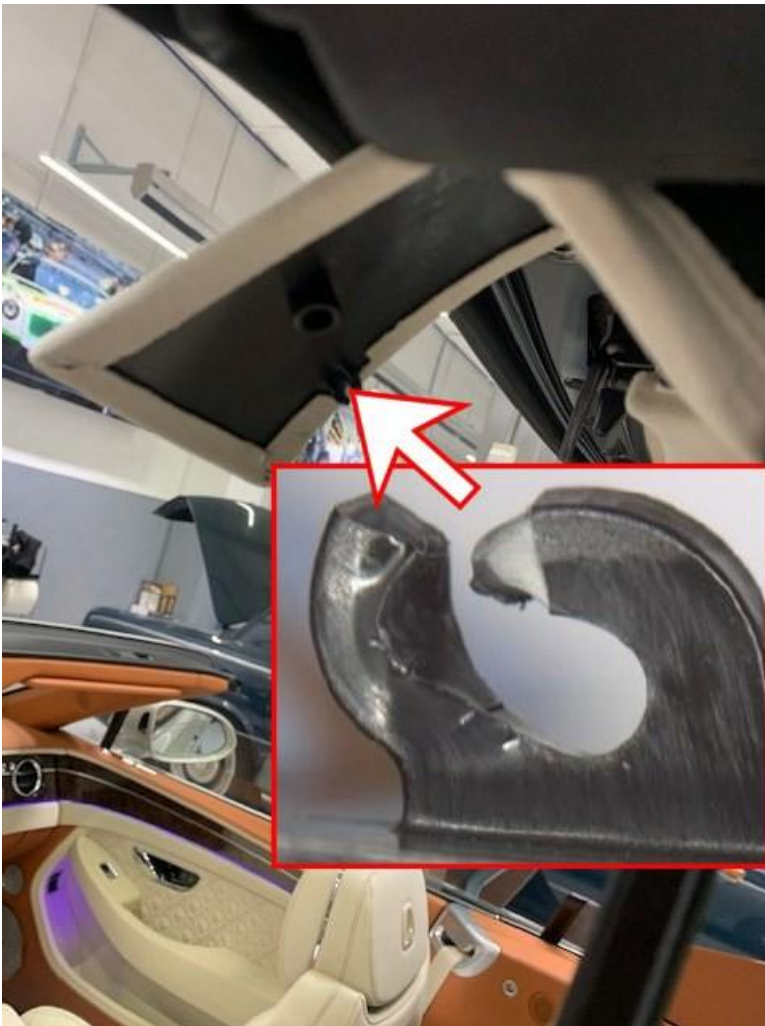
Figure 1

Convertible hood cannot close/latch due to a broken eyelet. The eyelet is part of the trim flap assembly (Figure 1)

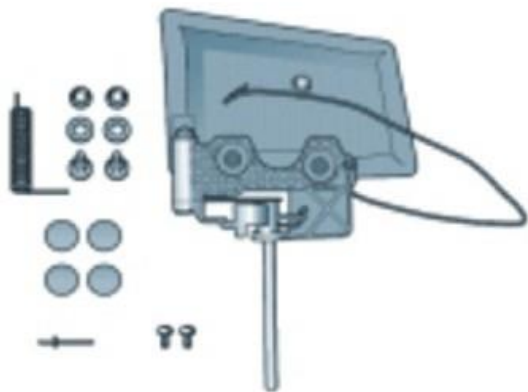
Figure 2

A kit of parts to replace the right and left hand trim flaps is now available (Figure 2)

NOTE: The trim flaps should be replaced in pairs

1) Replace the right and left hand trim flaps - Rep.Gr 61

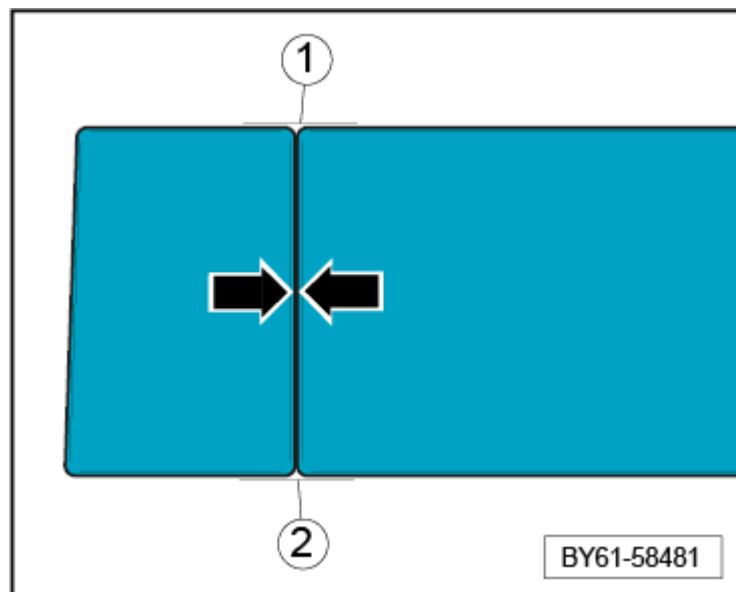
Misalignment of the panels can cause damage to both the header trim panel and the header trim panel flap assembly.

- Align the flap assembly to the header trim panel, ensuring that the edges **-1-** of the two panels align, and that the gap **-arrowed-** between the two panels is 2.5mm (+0.5/-1.5) and consistent along the whole length .
