Tire Balance/Tire Road Force Balance Warranty

2018-2021 Expedition/Navigator Gap Hider Damage And TSB 21-2419

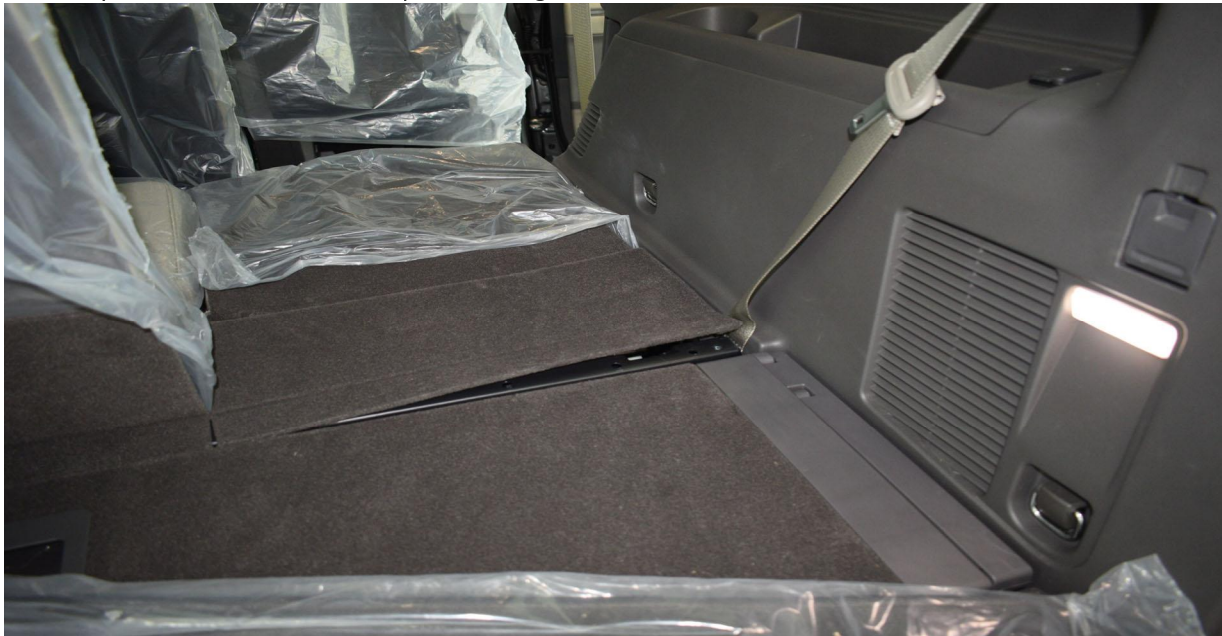
Some 2018-2021 Expedition/Navigator vehicles built on or before 02-Aug-2021 may exhibit a condition where the gap hidens (small panels attached to the load floor compartment designed to cover the gap in the floor) of the load floor compartment become detached and/or are damaged. Below is a photo of a detached gap hider. Ford warranty has experienced several cargo management systems replaced in warranty that could have been repaired using TSB 21-2419.
