TECHNICAL SERVICE BULLETIN

Rear Bumper Cover To Quarter Panel Poor Fitment And/Or Excessive Body Gap

23-2302

Ford
2024 Mustang

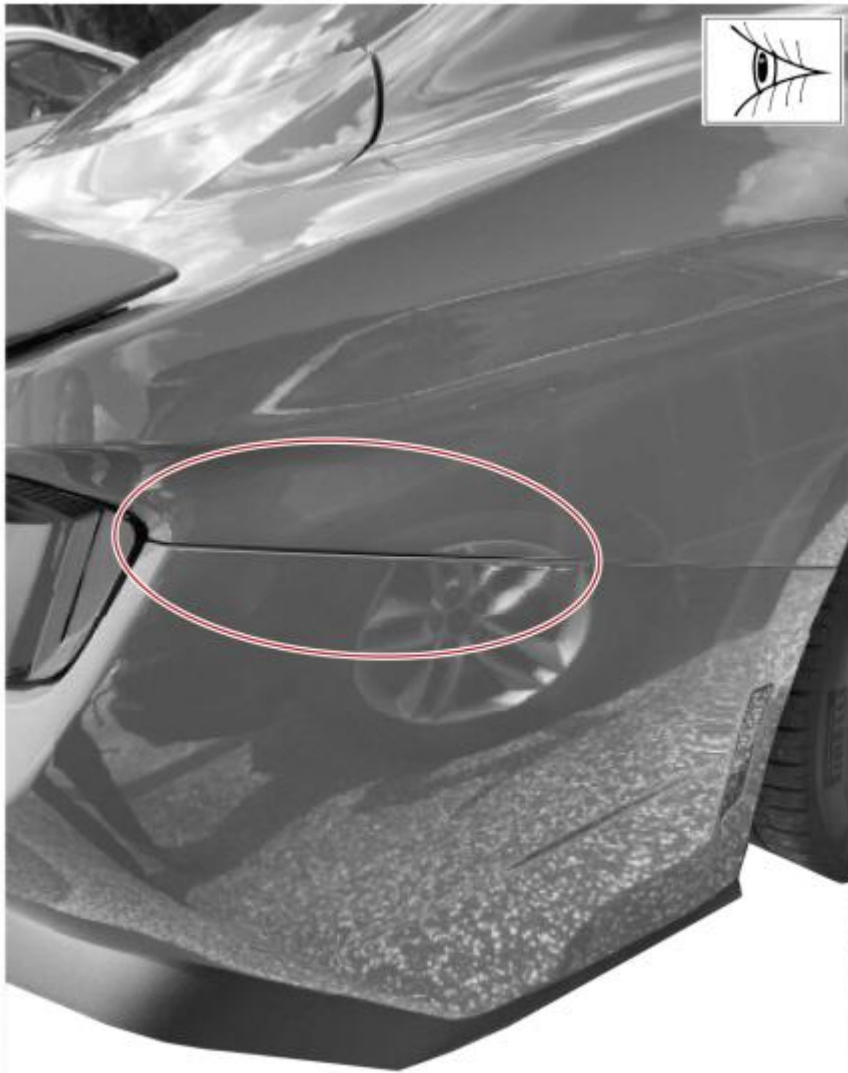
Figure 1 - Area of concern shown

Issue: Some 2024 Mustang vehicles may exhibit a condition where the rear bumper cover has poor fitment and/or excessive body gap where it meets the quarter panel. This may be due to incorrect installation and/or missing panel adhesive tape. To correct this condition, follow the Service Procedure to apply panel adhesive tape and re-install the rear bumper cover.

1. Does the rear bumper cover have poor fitment and/or excessive body gap where it meets the quarter panel as shown in Figure 1?
