TECHNICAL SERVICE BULLETIN

Instrument Panel (IP) Topper Rub/Scratch/Buzz Noise From Right Front Passenger Side - Built On Or Before 29-June-2023

23-2311
02 October 2023

Ford 2024 Mustang	Built on or before 29-June-2023
----------------------	---------------------------------

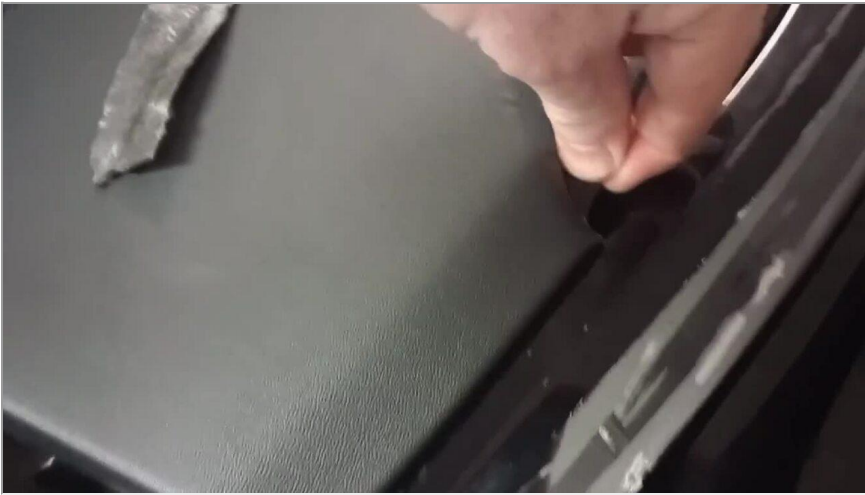
Video 1 - Example of IP topper scratch noise with windshield taken out

1. Does the IP topper make a rub/scratch/buzz noise from the forward right section directly adjacent to the defroster grille? Refer to Videos 1 and 2 for examples.

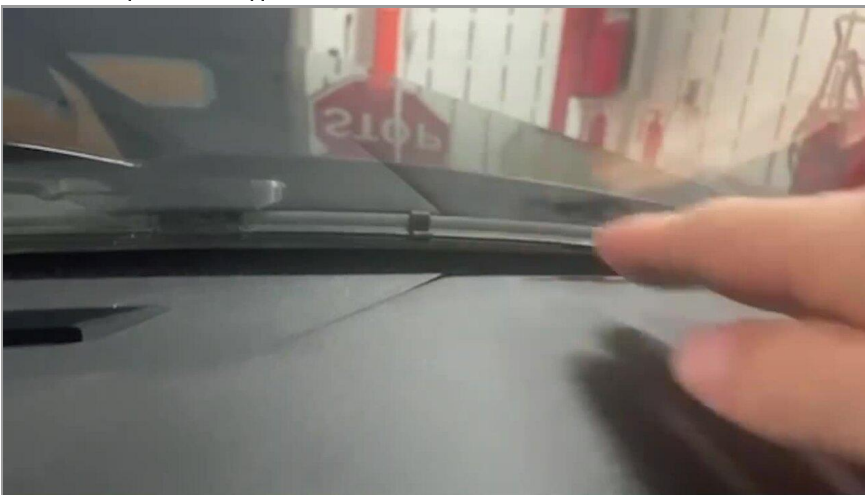
Video 2 - Example of the IP topper scratch noise in vehicle

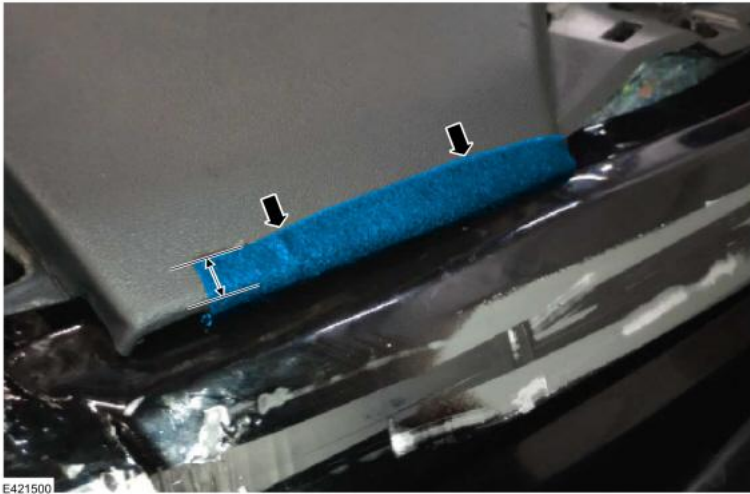
Figure 1 - View from right side of the vehicle with flock tape installed

5. Obtain a full section (6 in. long x 1.75 in. wide x .0625 in. thick) of flock tape (fuzzy) strip tape from the Rotunda Squeak and Rattle Kit or obtain flock tape separately from the kit. Wrap the flock tape around the leading edge of the IP topper as seen in Figures 1-2 with only 10 mm of the flock tape should be exposed on the top side of the IP topper, isolating the IP topper from directly touching the sheet metal.

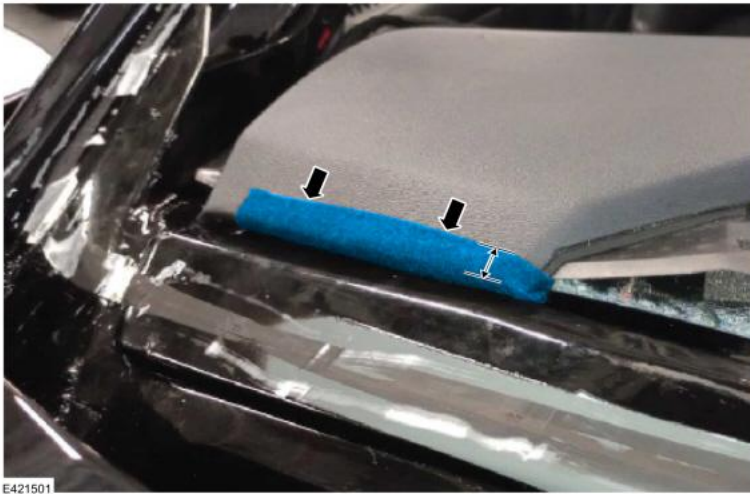
Figure 2 - View from left side of the vehicle with flock tape installed
