GROUP	MODEL
ELE	2024MY Sportage (NQ5, NQ5a)
NUMBER	DATE
315	October 2023

TECHNICAL SERVICE BULLETIN

4.2 IN. INSTRUMENT CLUSTER

SOFTWARE LOGIC IMPROVEMENT (SA547)

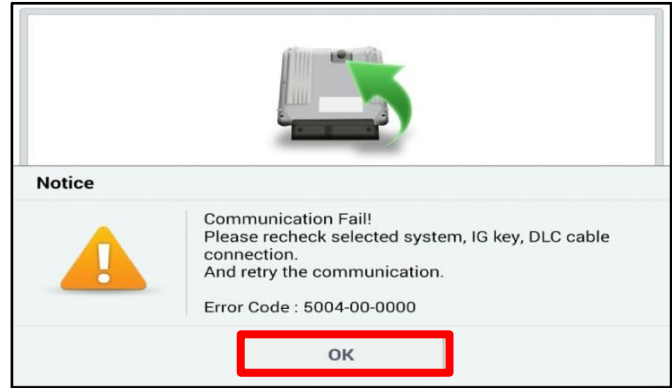
- If a "Communication Fail" screen appears, verify that the VCI-II and KDS are communicating properly. Select 'OK' and restart the from step 4.

If an error notice continues to appear or if the upgrade cannot be performed, DO NOT disconnect the KDS/VCI-II. Contact GIT America Help Desk at (888) 542-4371 or Techline.
