TECHNICAL SERVICE BULLETIN

Chatter/Shudder During Low Speed Turning Events

23-2335

26 October
2023

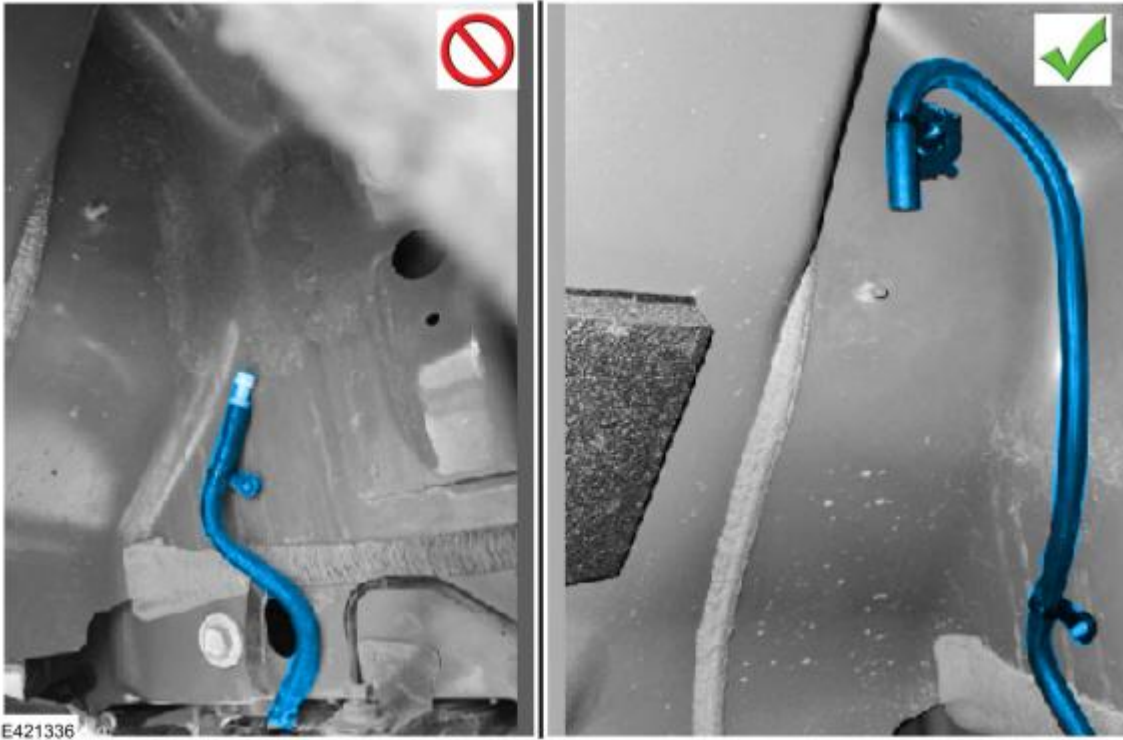
Figure 3

2. Inspect the RDU vent hose mounted behind the right rear fender splash shield. Is the vehicle equipped with the updated RDU vent hose as shown in the image with the green check mark in Figure 3?
