SV Signature Suite – 2nd Row Deployable Table Not Stowing

Range Rover

- 23MY Range Rover (SV model variants Only)

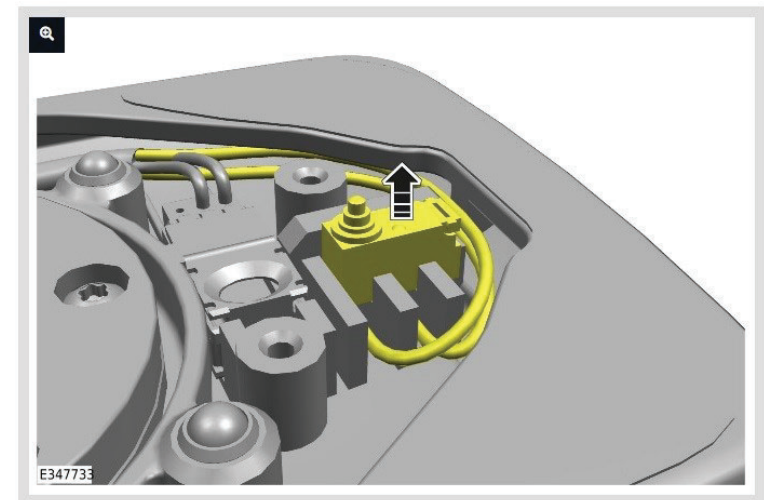
- The 2nd row deployable table is not stowing and stays deployed.

- The deployable table for the 2nd row seats may not stow once deployed due to a fault with a microswitch in the table assembly.

- The microswitch has now been made serviceable less the complete table assembly.
- **SSM 76094** has been published to address this concern, providing repair guidance.
