SERVICE BULLETIN

NUMBER: 15-314-23

SUBJECT: Apple CarPlay & Android Auto application performance with Gen 3.1 Harman Head Unit
 -Auxiliary USB Terminal / Design Change

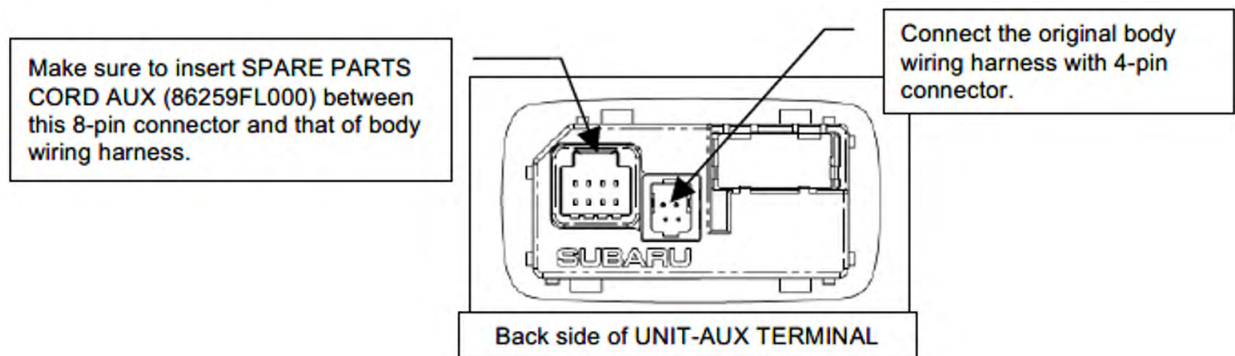
This Service Bulletin is to inform you of the availability of the new auxiliary USB terminal and adapter cord designed to address cases of intermittent communication loss when using Apple CarPlay and/or Android Auto application connected via the auxiliary USB terminal port (2-port type) to Gen 3.1 Harman Head Unit. When using a USB cable to connect a smart phone to the auxiliary USB terminal, the data between the external device and the Head Unit can possibly be disturbed resulting in connection loss. If this occurs, the Head Unit software cannot reestablish the connection automatically. If this symptom is reported, follow the service procedure outlined below.

STEP 2: Insert adapter cord (86259FL000) between the original body wiring harness (with 8-pin connector) and the new auxiliary USB terminal as the pin location on the new terminal is different from the original one. The original body wiring harness with 4-pin connector can be used without adapter cord.
