**SERVICE BULLETIN**

**APPLICABILITY:** 2019-23MY Impreza  
 2019-23MY Crosstrek (Including Hybrid Model)  
 2019-23MY Forester  
 2019MY Legacy/ Outback  
 2019-21MY WRX  
 2019-21MY WRX STI  
 2019-21MY BRZ- Navigation -equipped ONLY  
 2019-22MY Ascent

**NUMBER:** 15-236-18R

**SUBJECT:** Reprogramming File Availability for Optimization of Harman Gen 3.1 and Gen 3.1α Audio and Navigation Head Units

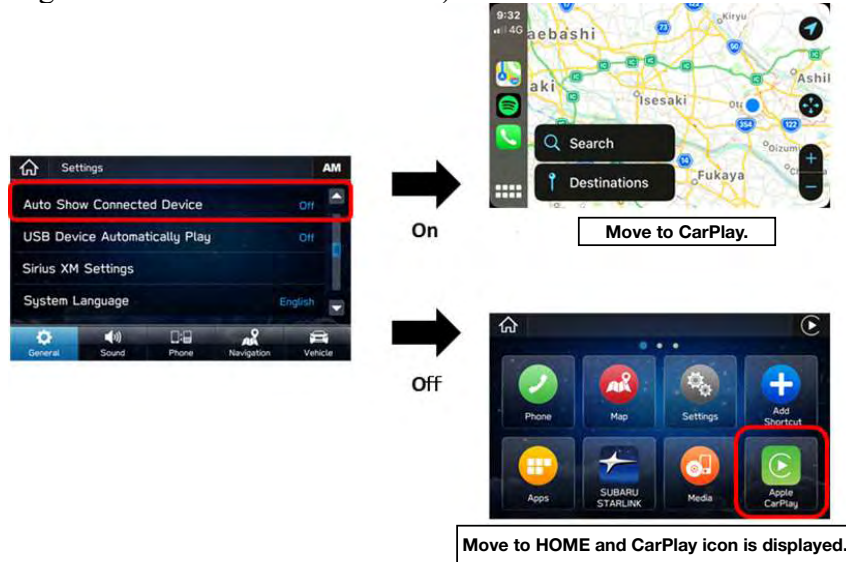
In a case where the iPhone was disconnected while playing music then reconnected while it is playing music, the system moves to CarPlay screen no matter what is set in <Auto Show Connected Device> in Setting (depending on iOS version of the iPhone.)

The <Auto Show Connected Device> is no longer available for CarPlay. The Setting menu shows only <Android Auto> to access the <Auto Show Connected Device> selection menu. If an iPhone with active CarPlay is connected, the Head Unit always moves to the CarPlay screen.

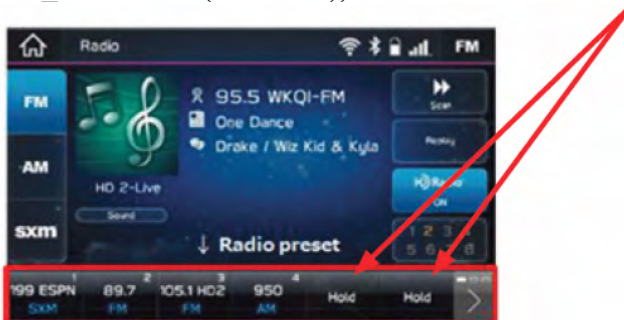
- 1) Station presets are lost. Touch buttons read “Hold”. (Applicable for software versions Rel\_4.18.25.50 (or before)). Included in software version Rel\_U1.18.38.50.
