SERVICE INFORMATION BULLETIN

APPLICABILITY: 2020-24MY Legacy & Outback
2019-24MY Forester

NUMBER: 12-248-23R

SUBJECT: Rattle-Type Sound From B-Pillar Area

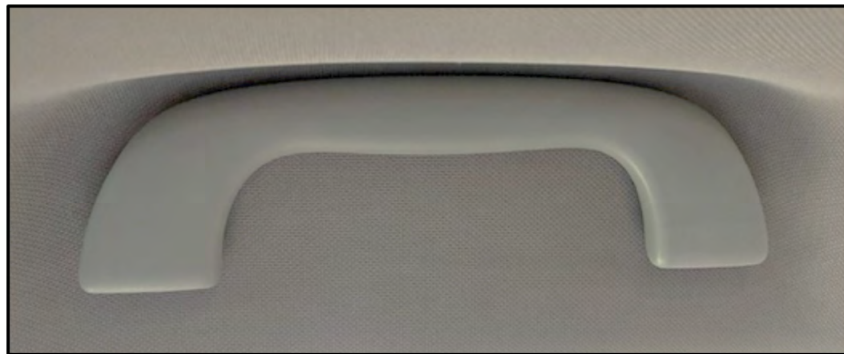
STEP 3: Remove the rear assist grip handle.

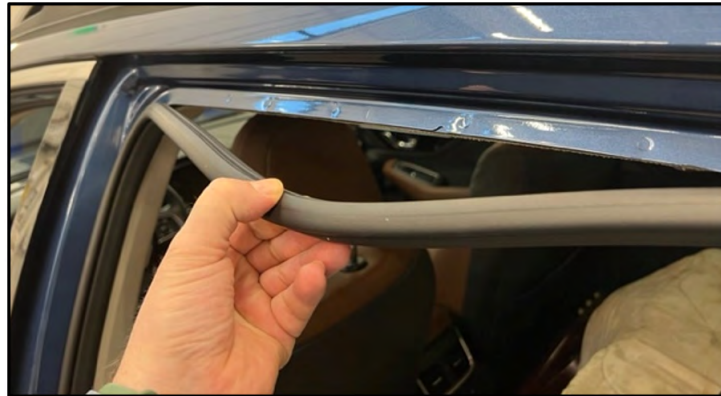
STEP 4: Detach the weatherstrip and CAREFULLY pull down the headliner to gain access to the curtain air bag inflator.

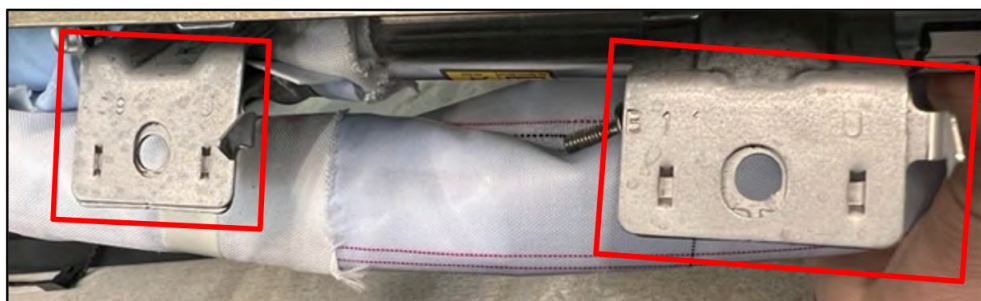
STEP 6: Clean the mounting brackets with a soft cloth and inspect the brackets for any burrs or rough spots. If found, even out with a light grit sandpaper or emery cloth (100-210 grit for deburring and 400-600 grit for finishing) and then clean the brackets.

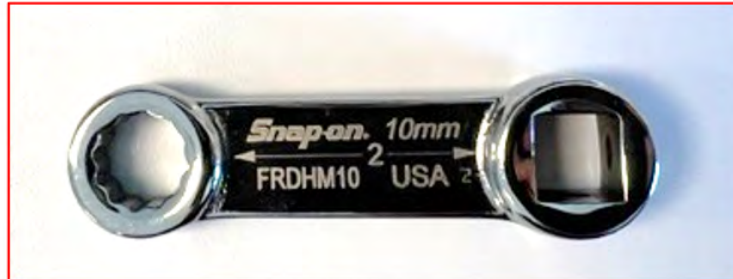
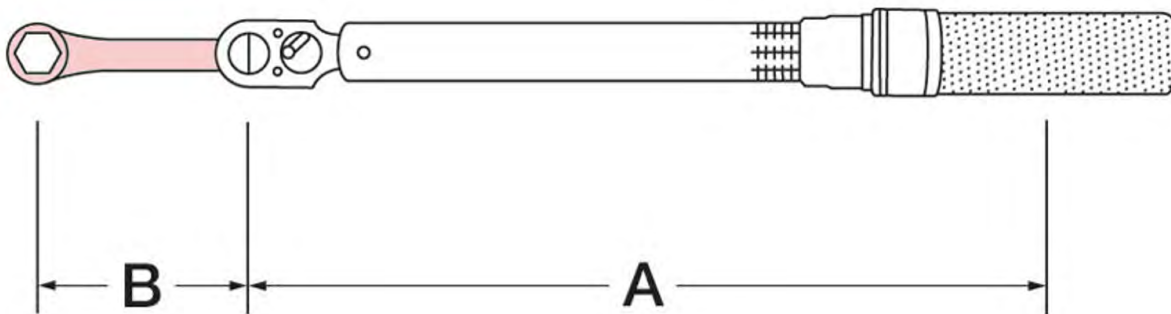
EXAMPLE: Snap-on® FRDHM10 Torque Adapter

STEP 7: Reinstall the curtain air bag mounting bolts and torque to 7.5Nm (5.5ft.-lbs. or 66inch-lbs.).

NOTE: Depending on the type of torque wrench being used a torque adapter may be required. If a torque adapter is used, the calculation formula supplied below **MUST** be applied.

Calculation Formula: $T = L / (100 \text{ mm (3.94)} + L) \times 7.5\text{Nm (5.5ft.-lbs. or 66inch-lbs.)}$.
