PRODUCT CAMPAIGN BULLETIN

APPLICABILITY: 2024 MY Impreza and Crosstrek

NUMBER: WRL-23R

SUBJECT: Safety Recall – Instrument Panel Harness Clearance

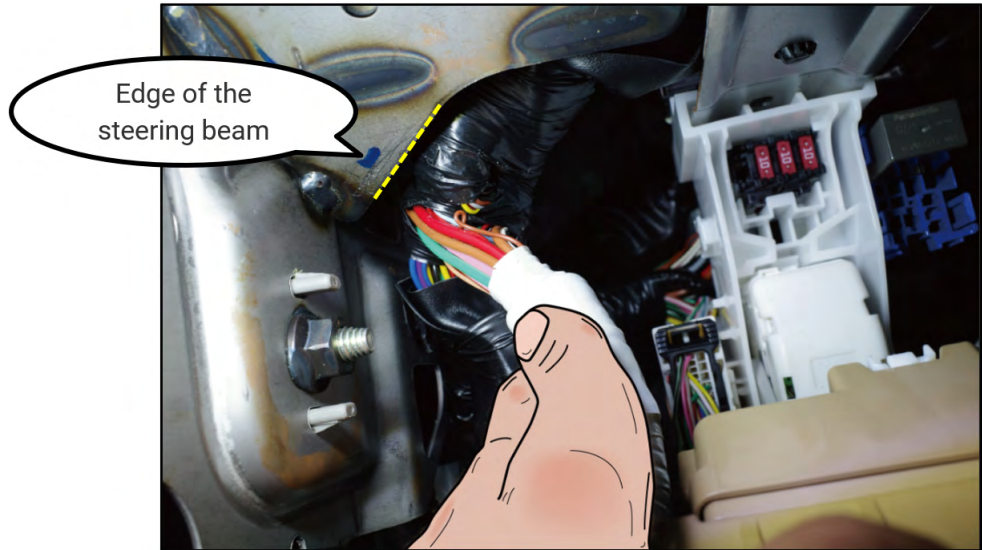
The affected vehicles have insufficient clearance around the instrument panel harness which may allow the harness to contact the steering beam bracket. If the harness contacts the bracket, the wire insulation could be damaged and/or a wire could short circuit.

STEP 7: Push the instrument panel harness downward by hand. CAREFULLY inspect the wires close to the edge of the steering beam bracket as shown in the picture below.

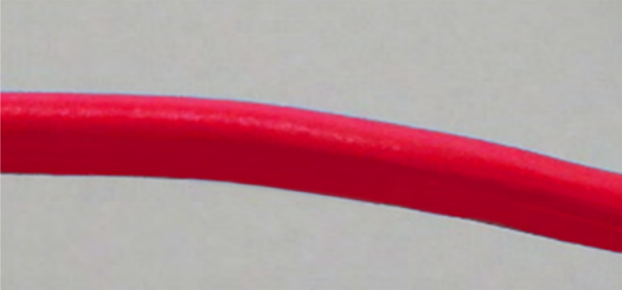
Inspection Result	Image	Next Step
No Damage Is Found.

Proceed To STEP 15
The Wire Insulation Is Damaged. (No Core Wire Is Exposed.)

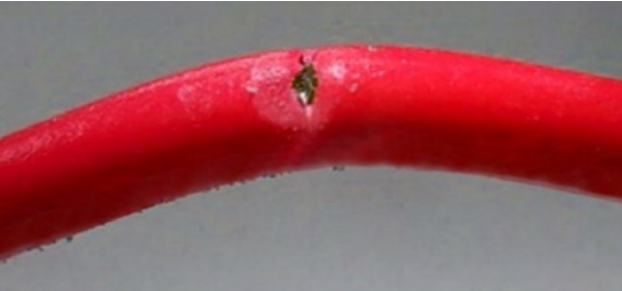
Proceed To STEP 8
The Core Wire Is Exposed.

Proceed To STEP 14

STEP 14: Remove the instrument panel assembly as per the applicable Service Manual and replace the instrument panel harness. Refer to STIS: Body & Electrical/WIRING SYSTEM > Instrument Panel Assembly

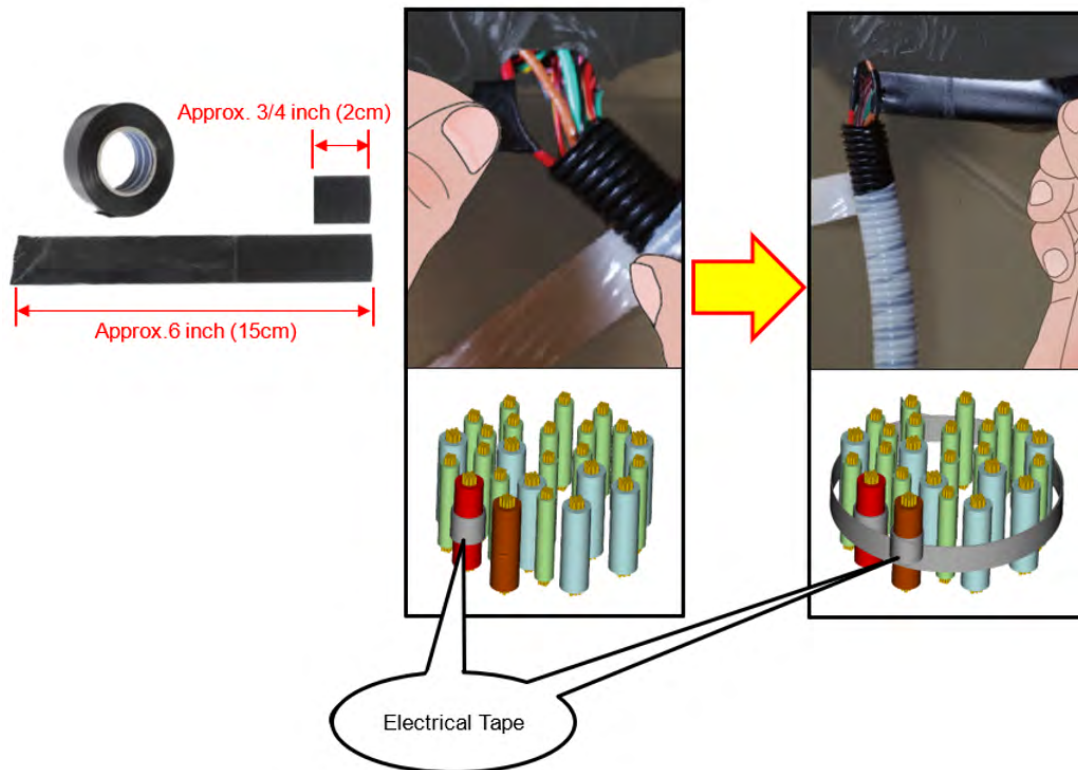
IMPORTANT NOTE: If more than one wire has damaged insulation.

- Pre-cut the electrical tape approximately 3/4 inch (2 cm) for each additional damaged wire.
- Pre-cut a 6-inch (15 cm) piece of electrical tape.
- Wrap the shorter pieces of tape around the additional damaged wiring.
- Wrap the end of the tape around the section of the wiring with the damaged insulation. Wrap the remaining tape around the entire wiring harness.
