Document ID: IK1300192
Revision: 0
Created: 10/2/2023
Last Modified: 10/13/2023
Author: Nicholas Pilotte

Title: Endurant Airline Plumbing Retrofit

Applies To: All Endurant equipped vehicles built before 11/1/2023

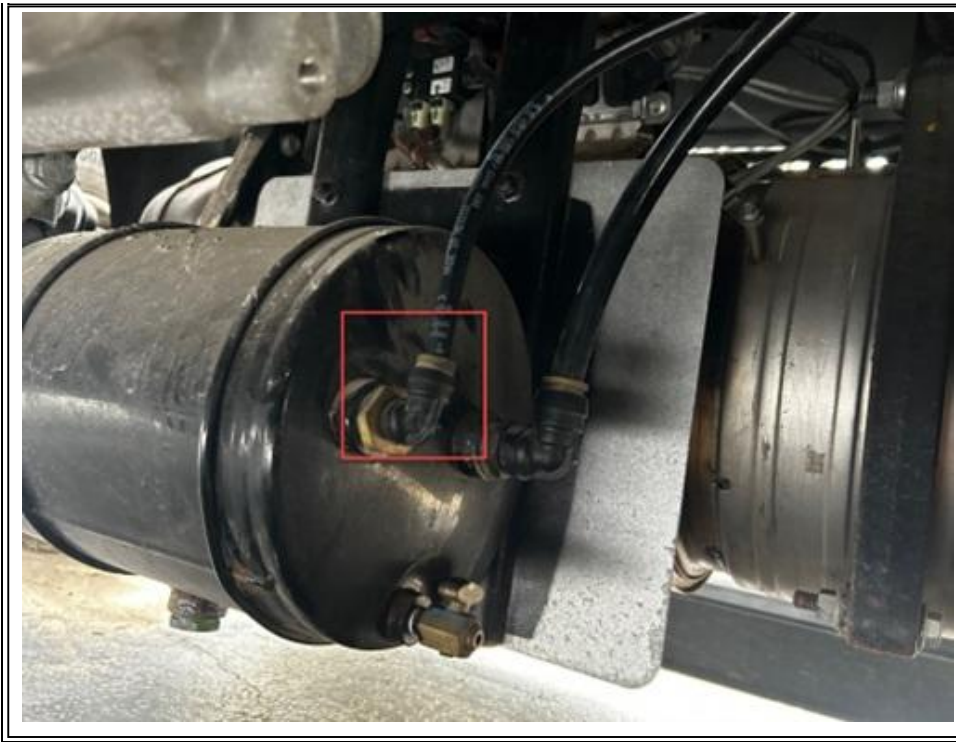
Figure 1

NOTE: This line connects to the air drier.

- 1.) Bring the vehicle into the shop and park on the flat surface.
- 2.) Set the parking brake and shift the transmission to neutral.
- 3.) Turn the vehicle ignition to the Key OFF position.
- 4.) Install wheel chocks.
- 5.) Discharge primary and secondary air tanks of all air pressure.
- 6.) From underneath the vehicle, discharge air pressure from the smaller auxiliary air tank using the drain valve - once fully drained, the valve must be closed again.
- 7.) Disconnect the black 3/8" airline from the auxiliary air tank and continue to remove it completely from the vehicle (Refer to Figure 1).
