Service Bulletin

Bulletin No.: 22-NA-133

Subject: Convertible Wind Noise at Rear Quarter Glass

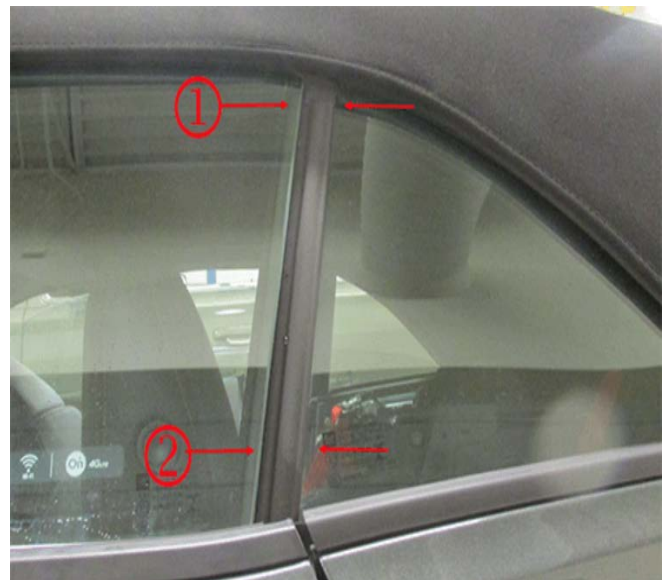
4805542

The first step in diagnosing a wind noise is to confirm the noise is actually coming from the side window area. Dealership technicians are to tape off this gap between the front side window and the rear quarter window. Test drive the car to verify the noise has been eliminated. If so, the quarter glass to front side window gap may be mis-adjusted. To correctly set the gap / location between the rear quarter window and the front side window, there are three measurements that must be checked / adjusted. The first two measurements are

actually both related to the vertical gap between the front side window and the rear side window. The vertical gap between these two windows is not parallel. It is actually "V-shaped" by design. When in the relaxed position, (folding top is stowed or in the lowered position) the gap at the top between the 2 windows is 12 mm wide, and the gap at the bottom of the glass between these two is actually 10 mm. This adjustment **MUST** be made with the folding top in the stowed or lowered position. The reason for this is when the top is closed and latched, it pinches the windows together and pushes the top of the quarter glass forward slightly. The result is an even, 10 mm gap between the two windows from top to bottom. This even gap can be seen in the photo above as the folding top is in the raised, or closed position.

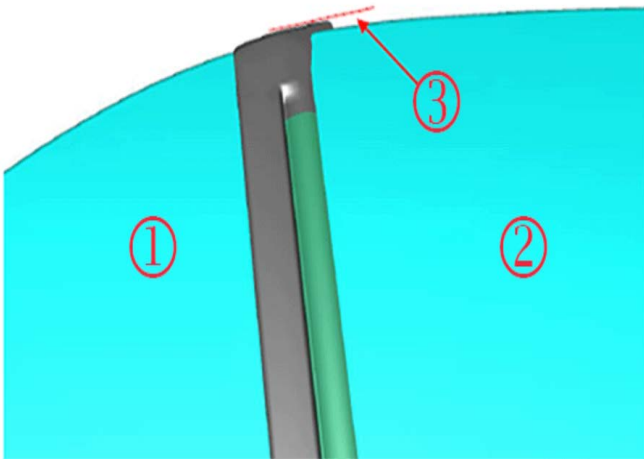
4784706

The third measurement / adjustment that must be made is the height of the rear quarter glass. It should be located so that it sits 4 mm higher than the front side window glass. This can also be seen in the photo above.

1. Rear Quarter Glass
2. Front Side Glass
3. 4 mm difference in height

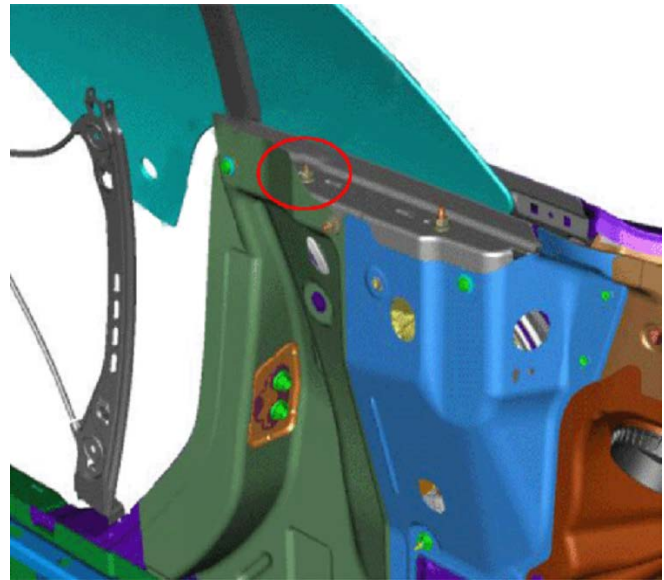
4784707

Once the quarter window is adjusted into position, compare the 2 panes of glass at the base to make sure they are flush with each other (inboard vs outboard). If the difference between the front and rear windows is more than 1.5 mm, or if there is a visible gap / daylight can be seen between the seals, the rear quarter glass needs to be adjusted further.

First, loosen the nut circled in the photo below. Then, gently push out on the base of the quarter glass to decrease this noticeable gap. Once the gap is within 1.5 mm of the front side glass, tighten this fastener down to 80 inch pounds (9 Nm) of torque. Do not push the glass out too far as this will result in additional glass alignment issues. Test drive the vehicle and determine if the noise has been eliminated or if more adjustment is needed.
