Technical Service Bulletin

GROUP	NUMBER
ENGINE	23-FL-006G
DATE	MODEL(S)
OCTOBER 2023	GV70 (JK1) 3.5T GV70 (JK1a) 3.5T GV80 (JX1) 3.5T

SUBJECT: COASTING MODE UPDATE (DELETE SOC CONDITION)

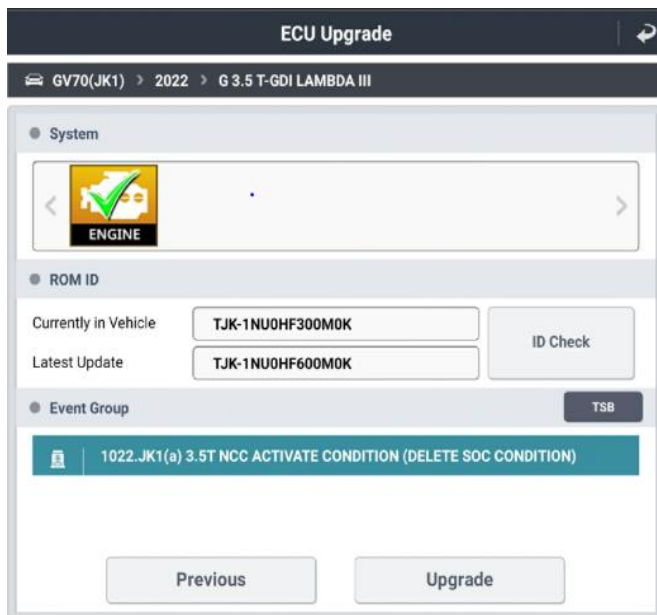
Use the Auto Mode ID Check to verify the ECU ROM ID before updating the software.

1. Perform the ECU Update in Auto Mode.
