Technical product information

Topic	Various and/or numerous Transmission control module DTC's logged - V8 Kovomo engine
Market area	Australia E04 Bentley rest Asia and Australia (6E04),China 723 Volkswagen (Anhui) Automotive CO (6723),China 796 VW Import Comp. Ltd (Vico), Beijing (6796),Germany E02 Bentley rest Europe (6E02),Japan E03 Bentley Japan (6E03),Korea, (South) E08 Bentley South Korea (6E08),United Arab Emirates E06 Bentley Middle East and Africa (6E06),United Kingdom E01 Bentley UK (6E01),United States E05 Bentley USA and rest America (6E05)
Brand	Bentley
Transaction No.	2061288/6
Level	EH
Status	Released for publishing
Release date	28-Sep-2023

New Continental GT/GTC - New Flying Spur - V8 Kovomo

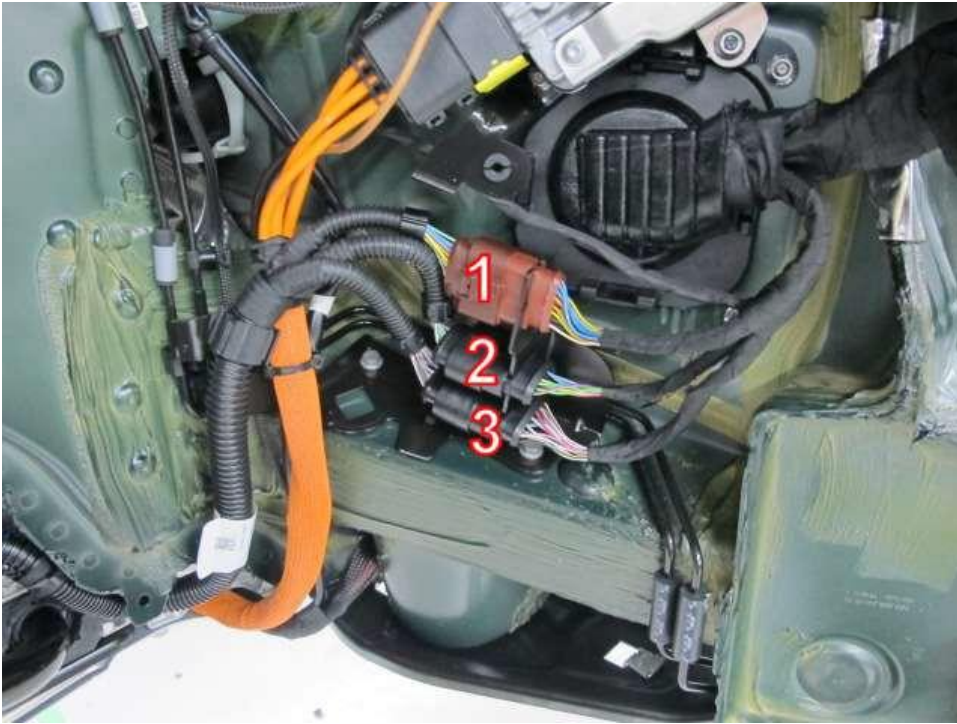
- Referring to Figure 2 - Disconnect the three connectors shown

2) Once disconnected carry out pin/terminal grab checks on all three male and female connections

- **In the event the main vehicle harness pins are not to specification the applicable pins should be replaced**
- **Should any issues be found with the transmission link harness and/or pins – the harness should be replaced**
- **IMPORTANT NOTE:** In the event the pins are to specification or the applicable repairs have been done (for example - Harness replacement or pin replacement) - Reconnect all three connectors (Figure 2) and proceed to Step 3
