## Technical product information

<b>Topic</b>	DTC's P014800 and/or P008A00 - Rough running & potentially poor start up performance - MIL light on - Possible misfires
<b>Market area</b>	Australia E04 Bentley rest Asia and Australia (6E04),China 723 Volkswagen (Anhui) Automotive CO (6723),China 796 VW Import Comp. Ltd (Vico), Beijing (6796),Germany E02 Bentley rest Europe (6E02),Japan E03 Bentley Japan (6E03),Korea, (South) E08 Bentley South Korea (6E08),United Arab Emirates E06 Bentley Middle East and Africa (6E06),United Kingdom E01 Bentley UK (6E01),United States E05 Bentley USA and rest America (6E05)
<b>Brand</b>	Bentley
<b>Transaction No.</b>	2062016/5
<b>Level</b>	EH
<b>Status</b>	Released for publishing
<b>Release date</b>	03-Oct-2023

### New Continental GT/GTC and New Flying Spur - W12 TSI only

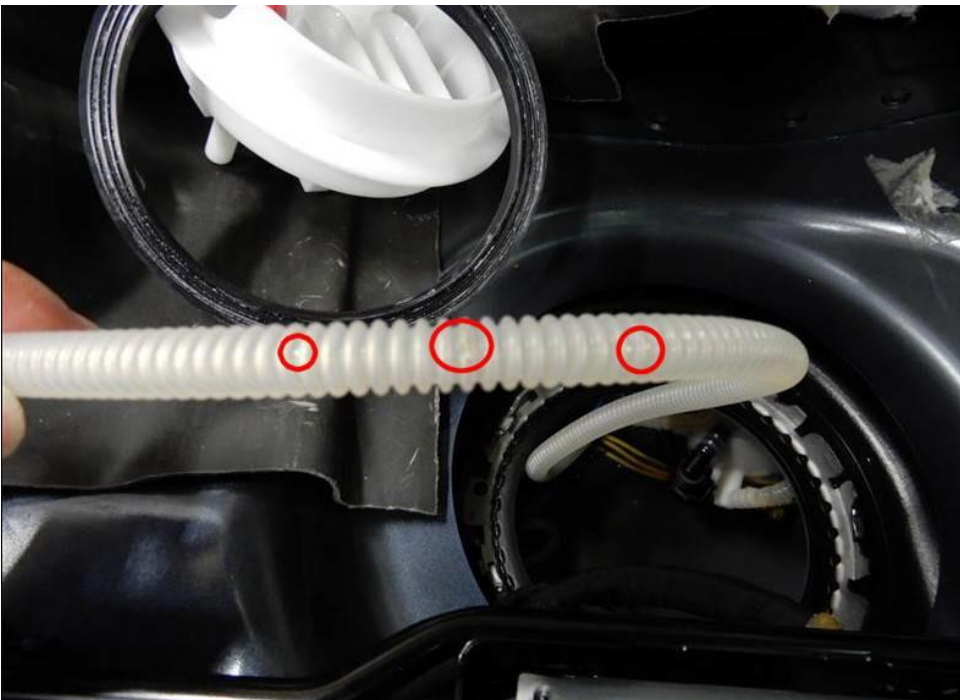
- Inspect the Fuel supply module and fuel filter fitment for detached hoses, damaged hoses and line and/or concerns with the module itself such as damage or leakage
- Figure 1 shows an example of a fuel tank internal hose with pin holes (circled)

9. Should any of the afore mentioned issues be evident the required parts should be replaced as necessary. However in the event that all previous checks were to specification the operative should conduct step 10 to completion.

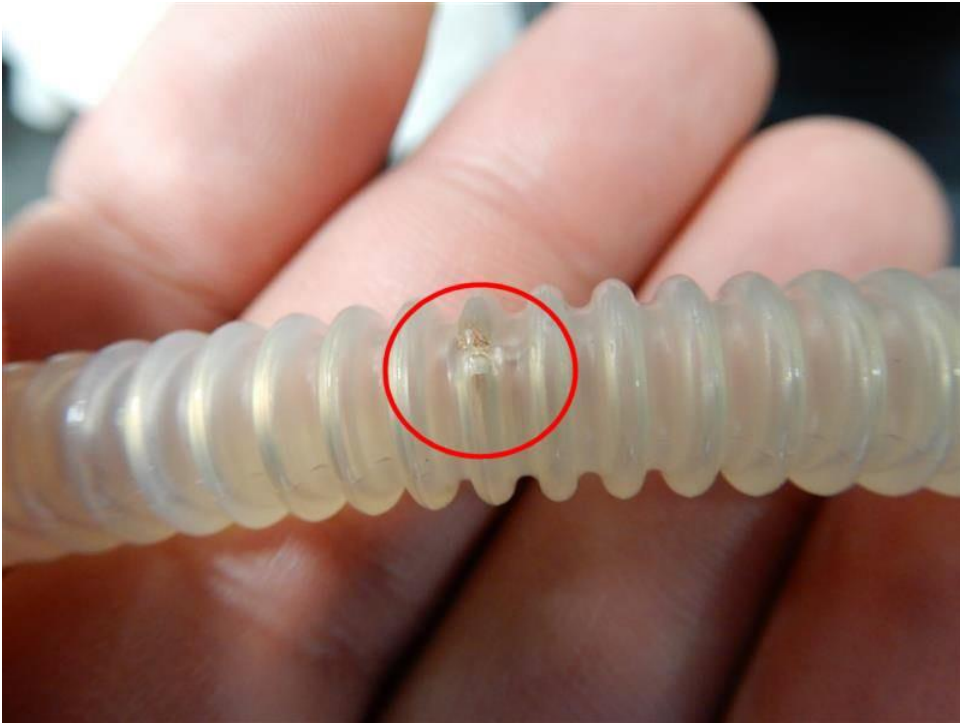
- Figure 2 shows a close up of the pin holes

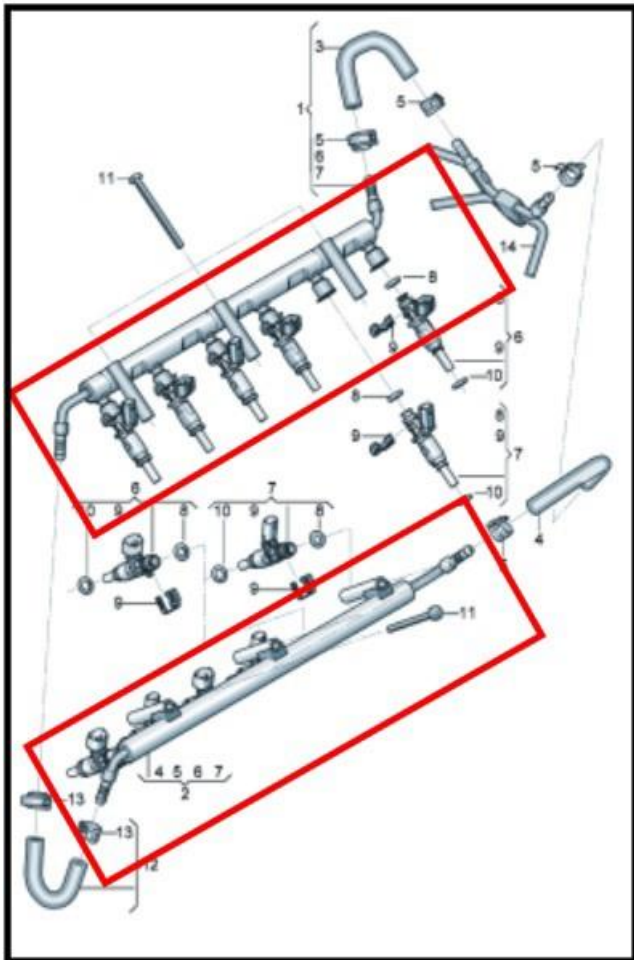
Figure 3

Debris in the fuel system can lead to a blockage in the low pressure fuel injectors, ultimately causing a cylinder misfire.

10. Replace both bank 1 and 2 low pressure fuel rails, the fuel rails come complete with injectors (Figure 3).
