RYKER MY23 - Checking the Bowden Cable (Parking Brake) Nut Tightening Torque - 142164

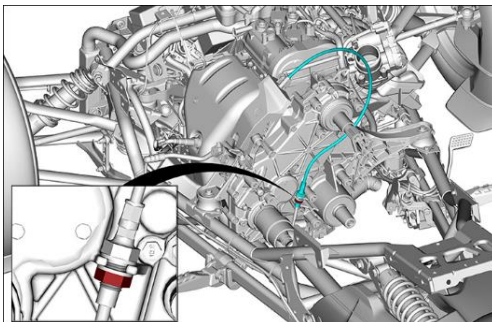
The tightening torque of the Bowden cable (parking brake) nut may not be adequate.

1. Pivot the body. Refer to *PIVOTING THE UPPER BODY MODULE* in the *BODY* section of the appropriate **online SERVICE MANUAL**.
2. Remove the CVT cover, drive belt, drive and driven pulleys and the CVT air guide. Refer to the *CVT* section of the appropriate **online SERVICE MANUAL**.
3. Check the tightening torque of the Bowden cable (parking brake) nut.

TIGHTENING TORQUE	
Cable nut	15 ± 2 N•m (133 ± 18 lbf•in)
