WPL8 - Replacing Electric Passenger Compartment Heater (Workshop Campaign)

Model Line: **Taycan (Y1A / Y1B / Y1C)**

Model Year: **As of 2020 up to 2023**

Concerns: **Electric passenger compartment heater**

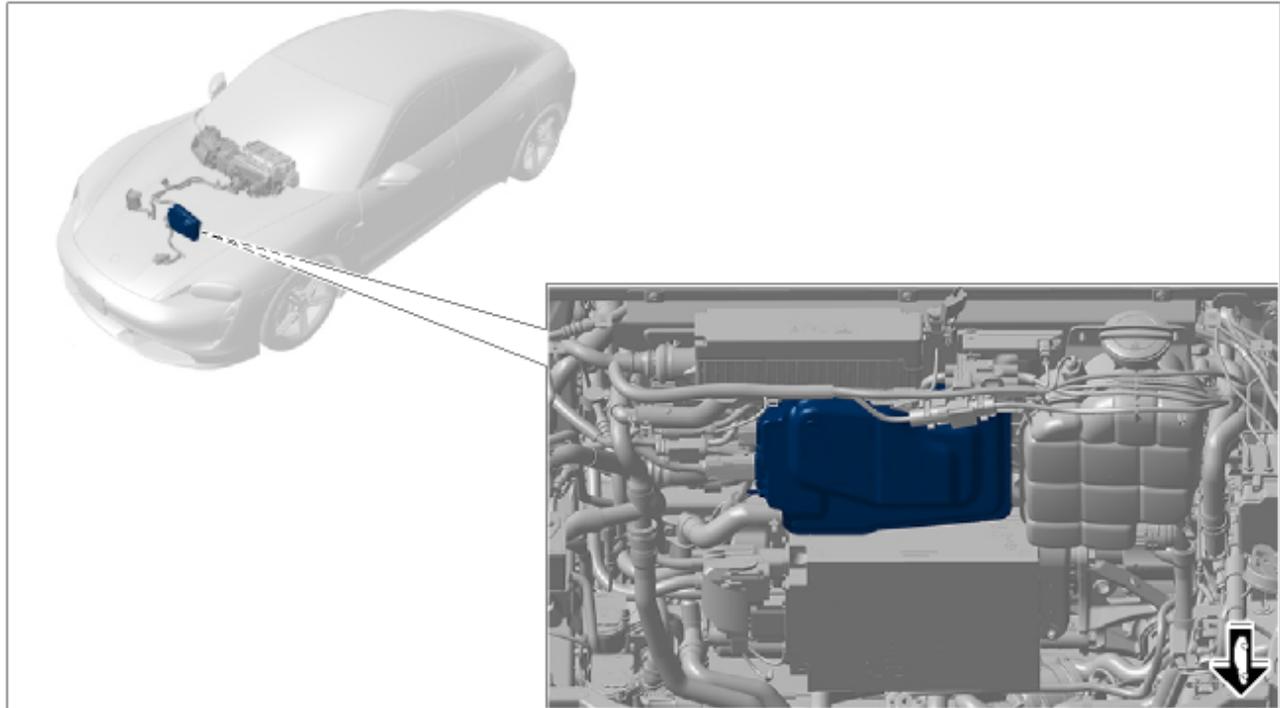
*Installation position*

Cause: **Due to a potential material error, the heater coating in the electric passenger compartment heater can become detached on the affected vehicles during prolonged utilization of the heating and with high heating output, especially in countries with frequently cold environmental conditions.**

This may result in the heating function being impaired and the vehicle not defrosting properly when driving.

– (Replacing) **Electric passenger compartment heater**

Action: Replace electric passenger compartment heater.
