Technical Service Bulletin

GROUP BRAKES	NUMBER 23-BR-003H
DATE OCTOBER 2023	MODEL(S) PALISADE (LX2 PE)

SUBJECT: SNOW MODE ACCELERATION S/W UPDATE FOR TCS LOGIC

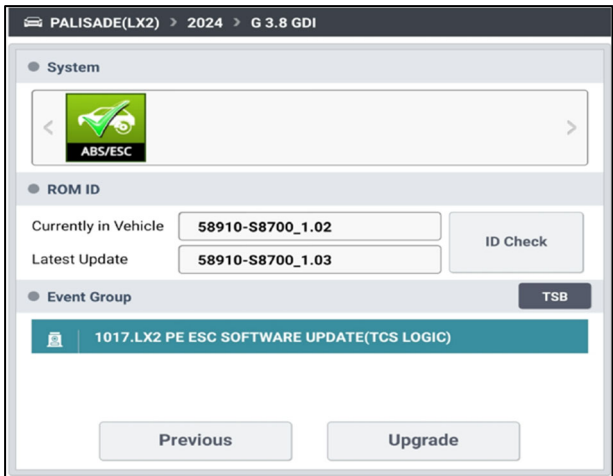
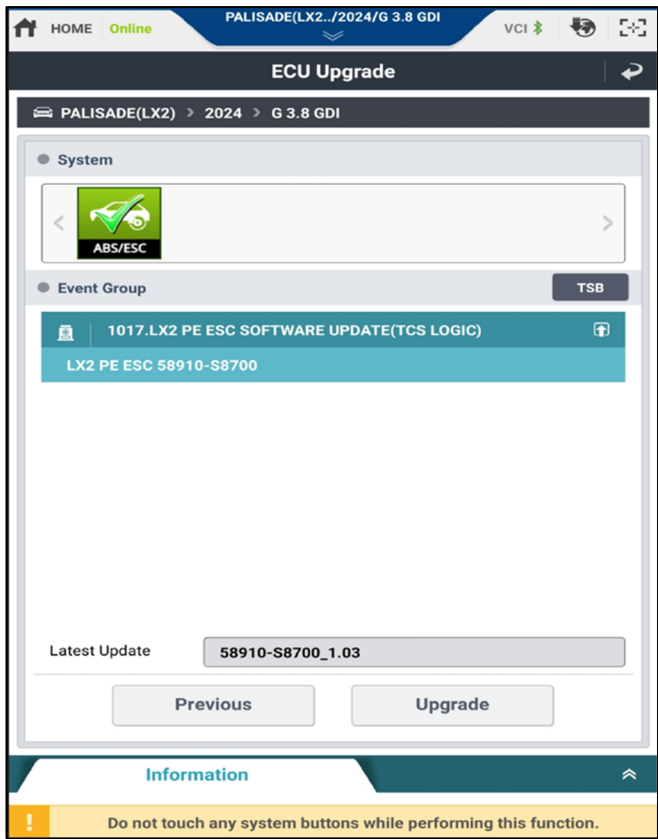
1. Perform the ECU Update in Auto Mode.

Use the Auto Mode ID Check to verify the ECU ROM ID before updating the software.

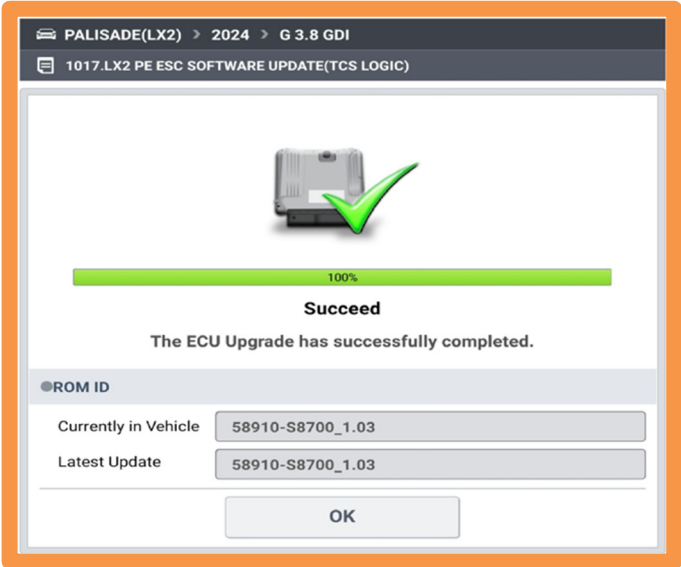
2.

Take a screenshot of the ECU Update Complete screen using your particular tablet's screenshot save method and upload to STUI.
