Technical Service Bulletin

GROUP	NUMBER
ENGINE	23-EM-006H
DATE	MODEL(S)
OCTOBER 2023	SANTA CRUZ (NXT)

SUBJECT: DTC P2181 – INTEGRATED THERMAL MANAGEMENT (ITM) REPLACEMENT AND ECU UPDATE

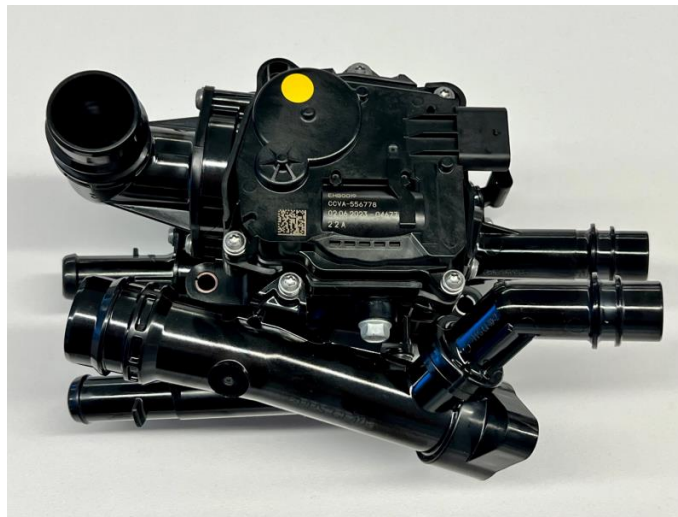
Description: Certain 2022-2023MY Santa Cruz (NXT) vehicles may experience a warning lamp illumination for a diagnostic trouble code P2181 that is related to the Integrated Thermal Management Module (ITM). Follow the service procedure outlined in this bulletin to replace the ITM with a revised part and reprogram the powertrain control module to update the control logic.

NOTE: Completion of both ITM replacement using the part listed below and ECU update to revise the control logic is required for the repair of P2181 “Cooling System Performance” condition.
