**HYUNDAI**
Technical Service Bulletin

GROUP CAMPAIGN	NUMBER 23-01-085H
DATE NOVEMBER 2023	MODEL(S) TUCSON (NX4A) SANTA CRUZ (NXT)

SUBJECT: WINDSHIELD WATER LEAK REPAIR (SERVICE CAMPAIGN 9A6)

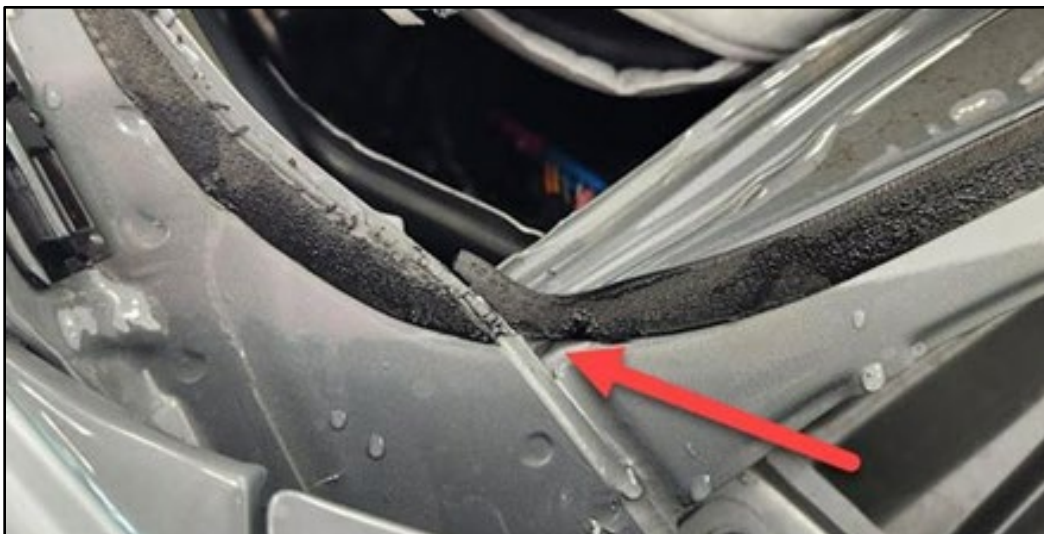
Description: Certain 2024MY Tucson (NX4A) and Santa Cruz (NXT) vehicles may exhibit water intrusion in the front passenger cabin from improper sealing of the windshield glass. This bulletin provides the procedures to fill in the gap of the urethane seal between the body and windshield glass.

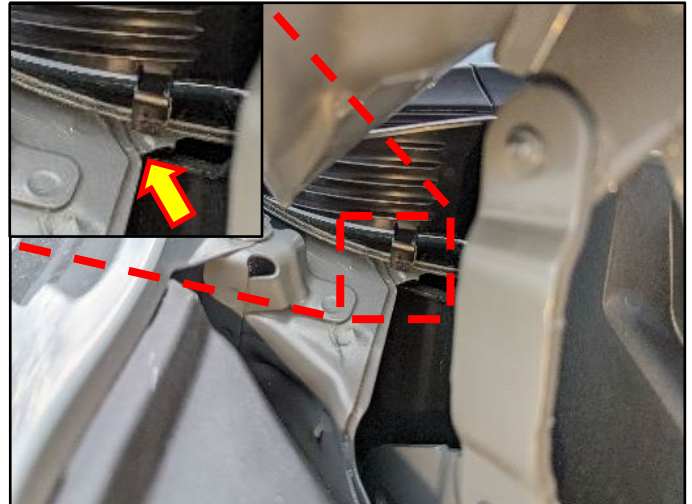
1. Open the hood and locate the A-pillar body panel seam near the hood hinge at the passenger side.
