Technical product information

Topic	Engine warning light illuminated within the DIP during acceleration - DTC P029900 evident - W12 TSI only
Market area	Australia E04 Bentley rest Asia and Australia (6E04),China 723 Volkswagen (Anhui) Automotive CO (6723),China 796 VW Import Comp. Ltd (Vico), Beijing (6796),Germany E02 Bentley rest Europe (6E02),Japan E03 Bentley Japan (6E03),Korea, (South) E08 Bentley South Korea (6E08),United Arab Emirates E06 Bentley Middle East and Africa (6E06),United Kingdom E01 Bentley UK (6E01),United States E05 Bentley USA and rest America (6E05)
Brand	Bentley
Transaction No.	2063954/5
Level	EH
Status	Released for publishing
Release date	03-Oct-2023

New Continental GT/GTC - New Flying Spur, Bentayga - W12 TSI

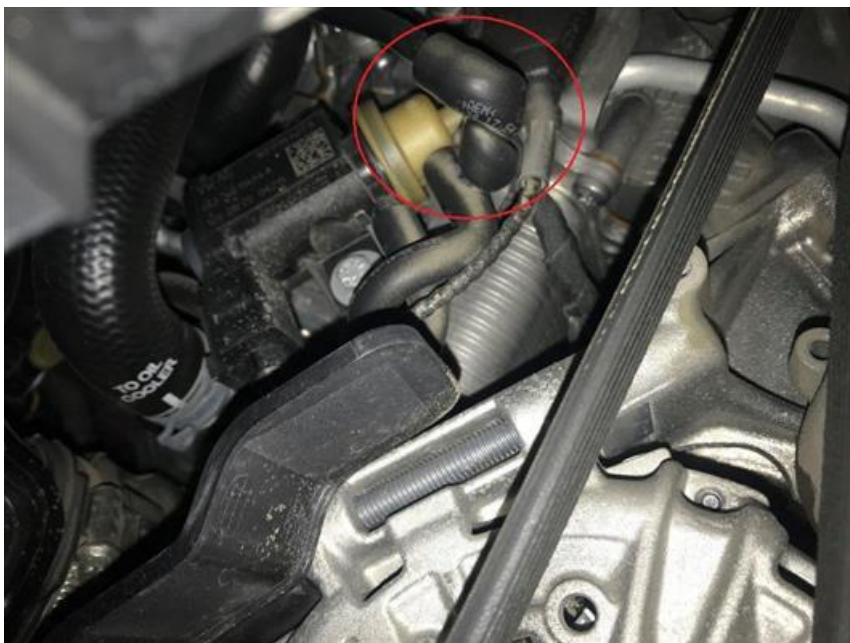
A kinked/damaged hose within the engine vacuum system

3) Carry out a visual inspection of the engine vacuum system TIP: Referring to the example shown in Figure 2, Check there are no kinks or damaged vacuum hoses

NOTE: The issue shown in Figure 2 is an example of a kinked vacuum hose which is fitted to the Boost pressure valve vacuum solenoid

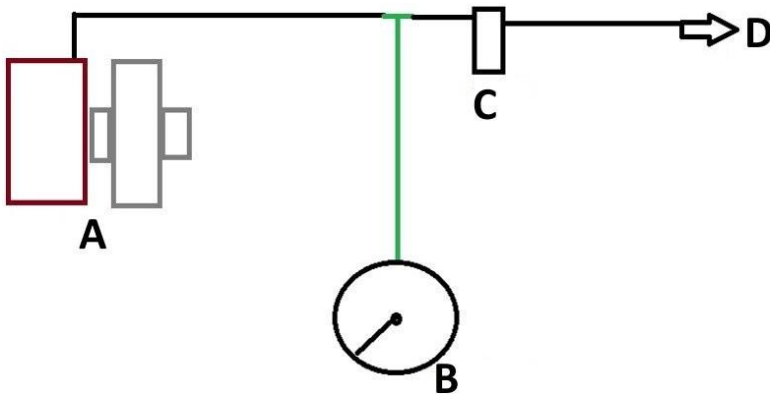
4) Referring to Figure 3 - Attach a manual vacuum gauge (B) between the following components: (Depending on the bank which is suspected to be at fault)

- Turbocharger wastegate (A) and (C) Boost pressure valve vacuum solenoid

NOTE: Point (D) refers to the engine vacuum system

The manual vacuum gauge must be connected as shown, the hose must be long enough to allow the gauge/readings to be viewed from inside the cabin

4) The vehicle should be driven whilst the second operative monitors the gauge to confirm if the Boost pressure valve vacuum solenoid is being actuated in a plausible manner **For example: Vacuum supplied to build boost pressure/vacuum supply closed when the target boost pressure is achieved**

If vacuum supply to the wastegate is not plausible the operative must check the vacuum supply to the Boost pressure valve vacuum solenoid
