Technical product information

Topic	Knocking noise from the front and/or rear (Driving over an uneven road surface)
Market area	Australia E04 Bentley rest Asia and Australia (6E04),China 723 Volkswagen (Anhui) Automotive CO (6723),China 796 VW Import Comp. Ltd (Vico), Beijing (6796),Germany E02 Bentley rest Europe (6E02),Japan E03 Bentley Japan (6E03),Korea, (South) E08 Bentley South Korea (6E08),United Arab Emirates E06 Bentley Middle East and Africa (6E06),United Kingdom E01 Bentley UK (6E01),United States E05 Bentley USA and rest America (6E05)
Brand	Bentley
Transaction No.	2064791/3
Level	EH
Status	Released for publishing
Release date	03-Oct-2023

New Continental GT/GTC and New Flying Spur

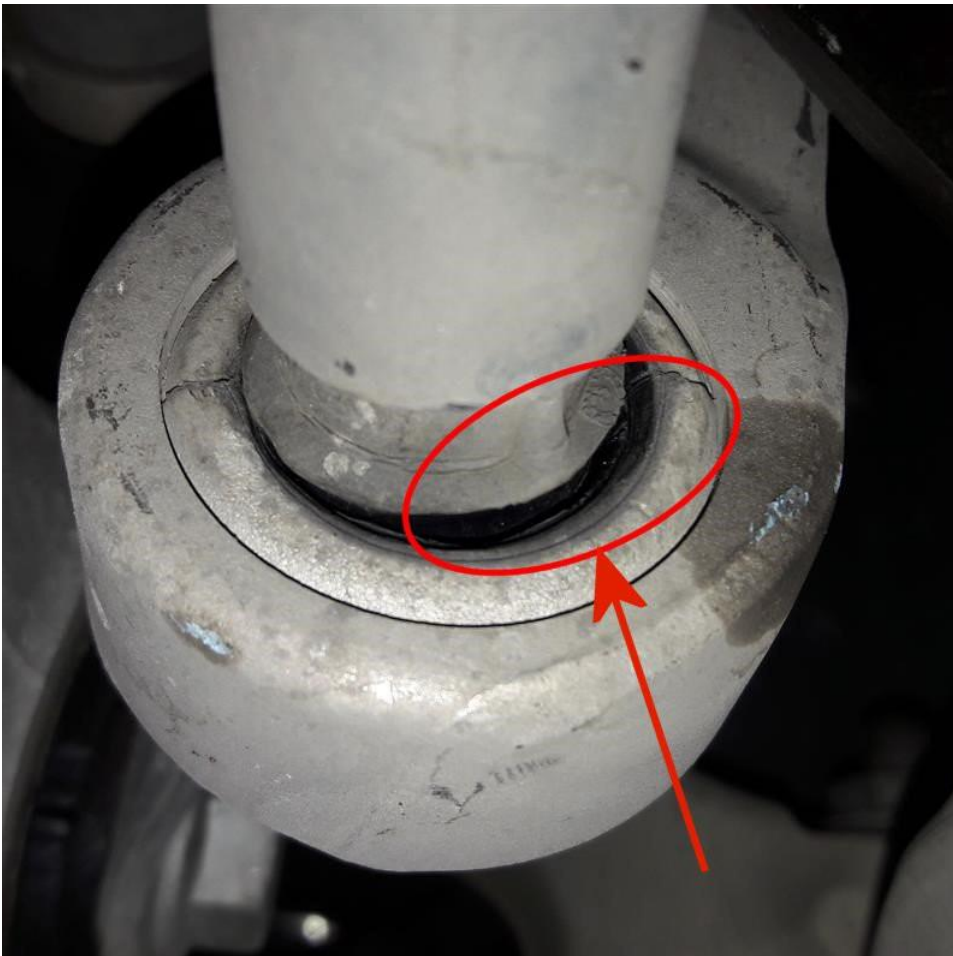
Figure 1

The noise present in the sound file can be caused by worn anti roll bar bushes, the noise can appear when driving over an uneven road surface or during a large suspension input for example:

- Worn front and/or rear anti-roll bar drop link bushes (Figure 1)

5) Referring to the applicable Rep.Gr - Replace the left and right drop links (front and/or rear)

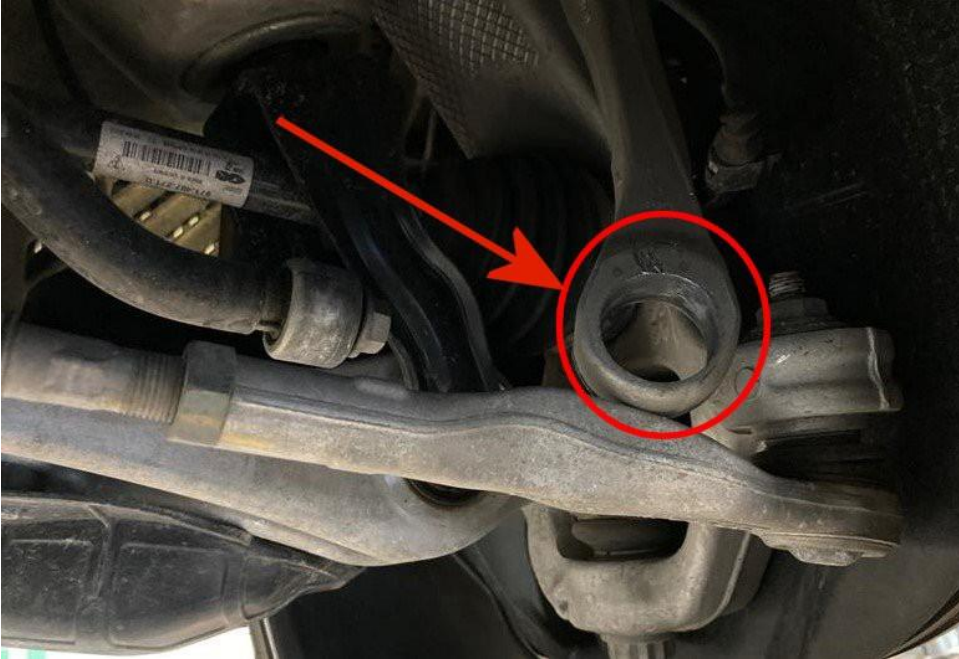
Figure 2

2) Check the front and/or rear anti roll bar drop link has not detached (Figure 2) in this scenario DTC (C1298F1: Suspension stabilization actuator Regulation not possible) may also be evident within address D4 and/or D5
