Technical product information

Topic	Knocking noise from the front and/or rear - DTC C1298F1 evident within D4 and/or D5
Market area	Australia E04 Bentley rest Asia and Australia (6E04),China 723 Volkswagen (Anhui) Automotive CO (6723),China 796 VW Import Comp. Ltd (Vico), Beijing (6796),Germany E02 Bentley rest Europe (6E02),Japan E03 Bentley Japan (6E03),Korea, (South) E08 Bentley South Korea (6E08),United Arab Emirates E06 Bentley Middle East and Africa (6E06),United Kingdom E01 Bentley UK (6E01),United States E05 Bentley USA and rest America (6E05)
Brand	Bentley
Transaction No.	2065085/3
Level	EH
Status	Released for publishing
Release date	03-Oct-2023

New Continental GT/GTC and New Flying Spur

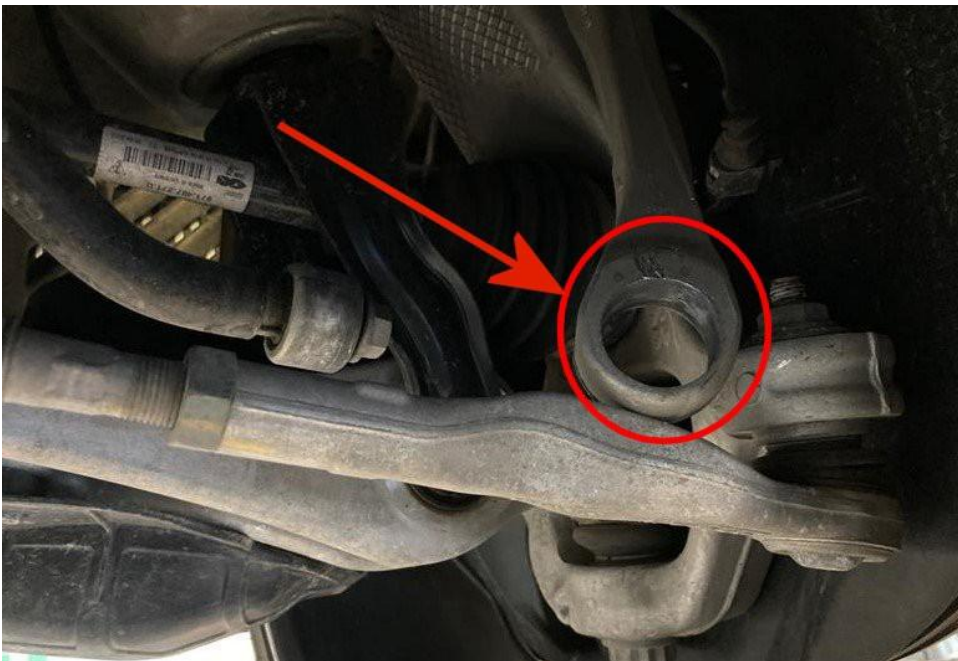
Figure 1

NOTE: The photo shown within this TPI is of the front anti roll bar drop link, please note the issue can also be evident on the rear

1) Check the front and/or rear anti roll bar drop link has not detached (Figure 1) in this scenario DTC (C1298F1: Suspension stabilization actuator Regulation not possible) may be evident within address D4 and/or D5

3) Raise a DISS query ensuring any photos and videos are attached of the issues found NOTE: The operative does not have to wait for a response before replacing parts - Referring to the applicable Rep.Gr - Replace the applicable drop link
