Technical product information

Topic	V8 Kovomo - Engine MIL light on - DTC 'P04F000: EVAP system high pressure purge line performance' evident
Market area	Australia E04 Bentley rest Asia and Australia (6E04),China 723 Volkswagen (Anhui) Automotive CO (6723),China 796 VW Import Comp. Ltd (Vico), Beijing (6796),Germany E02 Bentley rest Europe (6E02),Japan E03 Bentley Japan (6E03),Korea, (South) E08 Bentley South Korea (6E08),United Arab Emirates E06 Bentley Middle East and Africa (6E06),United Kingdom E01 Bentley UK (6E01),United States E05 Bentley USA and rest America (6E05)
Brand	Bentley
Transaction No.	2065148/3
Level	EH
Status	Approval
Release date

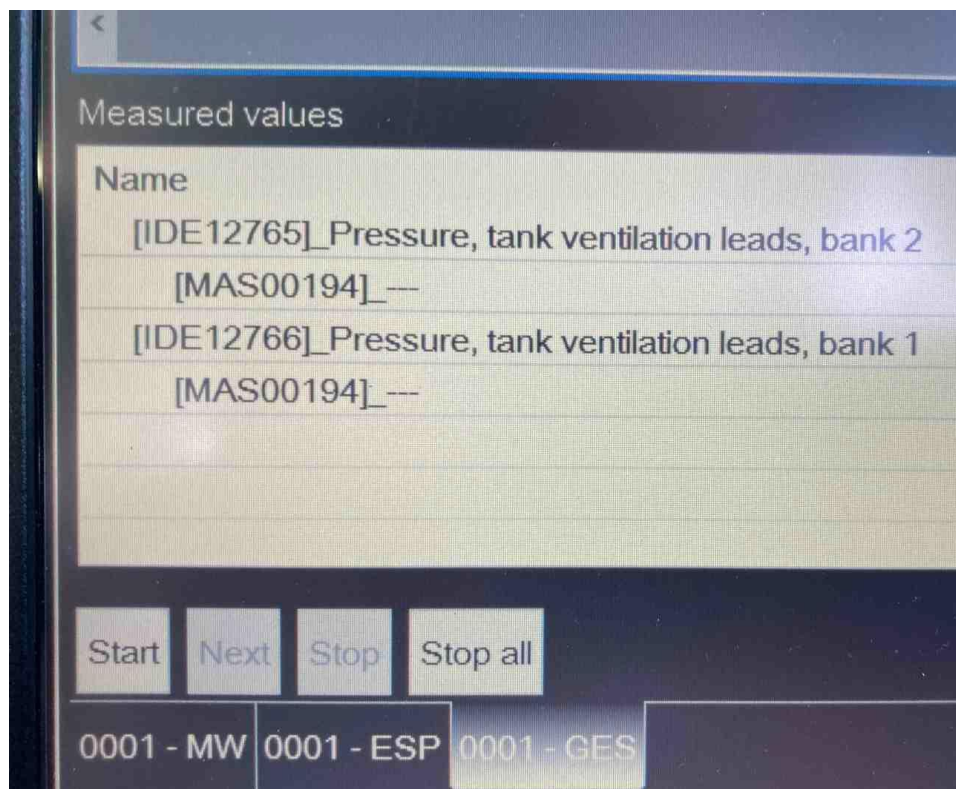
Figure 1

Observations when monitoring IDE12765 and IDE12766

Referring to Figure 1:

IDE12765 (When monitored) fluctuates from the static value found (Ignition on/Engine Off)

With/without purge activation

IDE12766 (When monitored) DOES NOT fluctuate from the static value found (Ignition on/Engine Off)
