Technical product information

Topic	Squeaking/creaking noises from the front axle and/or leaks at the lower ball joint/s
Market area	Australia E04 Bentley rest Asia and Australia (6E04),China 723 Volkswagen (Anhui) Automotive CO (6723),China 796 VW Import Comp. Ltd (Vico), Beijing (6796),Germany E02 Bentley rest Europe (6E02),Japan E03 Bentley Japan (6E03),Korea, (South) E08 Bentley South Korea (6E08),United Arab Emirates E06 Bentley Middle East and Africa (6E06),United Kingdom E01 Bentley UK (6E01),United States E05 Bentley USA and rest America (6E05)
Brand	Bentley
Transaction No.	2065197/3
Level	EH
Status	Released for publishing
Release date	03-Oct-2023

Bentayga Series

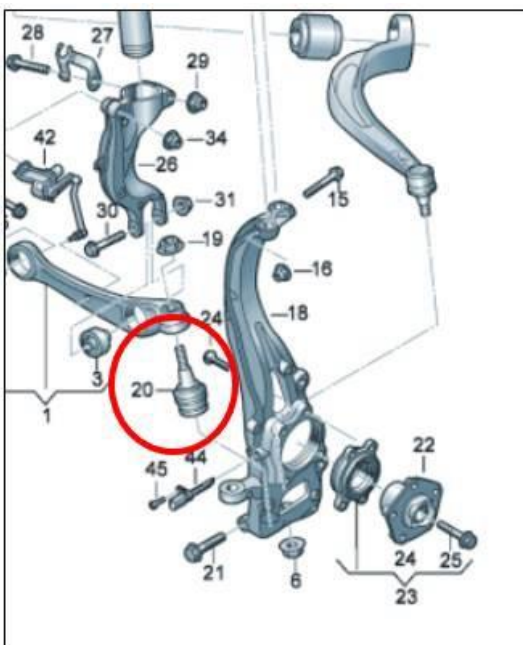
Figure 1

The noises can be assigned to the lower ball joint on the left and/or right side (Figure 1 - item 20).

Leak at the boot of the lower ball joint on the left and/or right side (Figure 1- item 20) is visible however the boot is undamaged.

NOTE: If the boot is damaged the lower ball joint must be replaced however warranty payments will not be permitted in this scenario

1) Referring to Rep.Gr 20 - Replace the left and/or right side lower ball joint

2) Carry out wheel alignment and ensure the driver assist system calibrations are performed (Depending on vehicle specification) as follows

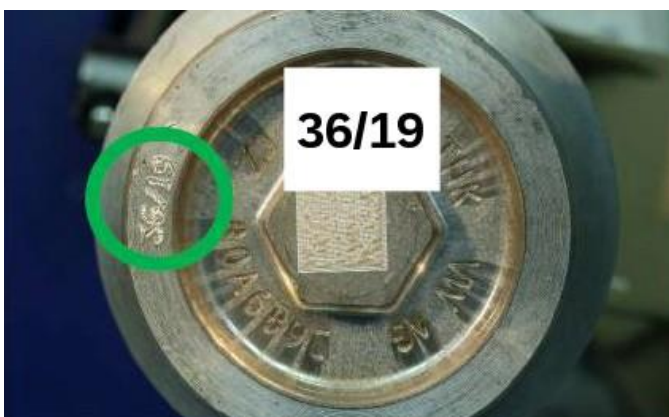
Make sure that the production date of the new ball joint is 36/19 or later (see date code example circled in Figure 2 - Week 36 of 2019).
