## Technical product information

| <b>Topic</b> | V8 Kovomo - Emission control warning illuminated within the DIP - Exhaust Gas Temperature Sensor DTC's evident |
| <b>Brand</b> | Bentley |
| <b>Transaction No.</b> | 2065698/3 |

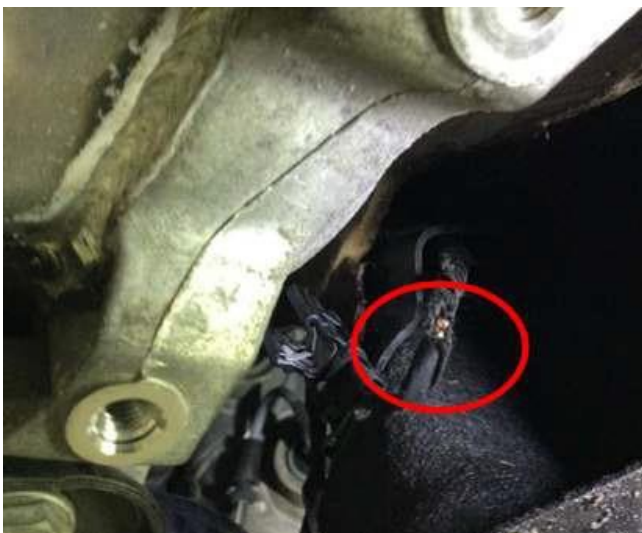
After further investigation the wiring harness leading to the Exhaust gas temperature sensor (Bank 1 and/or Bank 2) runs close to the sub-frame may rub/contact the edge of the bracket inside of the wheel arch cover/liner

See the examples shown in Figure 1 (Chaffed/damaged wiring Bank 1)

- 1) Check Bank 1 and Bank 2 Exhaust Gas Temperature sensor wiring harnesses for damage/chaffing
- 2) Referring to Rep.Gr 97 - Repair the applicable damaged wire(s)
- 3) Once repaired - Reposition and secure the Exhaust Gas Temperature sensor wiring harness, ensuring the harness cannot contact any surrounding components which could result in chaffing/damage

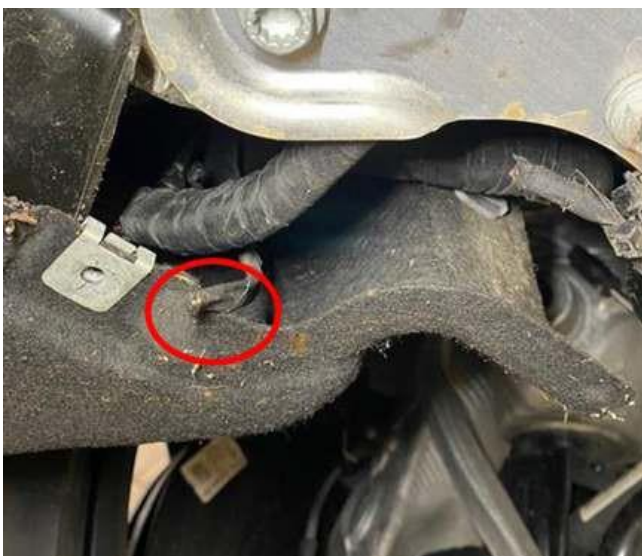
Figure 2 (Broken/damaged wiring Bank 2)
