Technical product information

Topic	Bentayga Hybrid - Emission control system warning lamp illuminated within the DIP - Potential wiring clash condition
Market area	Australia E04 Bentley rest Asia and Australia (6E04),China 723 Volkswagen (Anhui) Automotive CO (6723),China 796 VW Import Comp. Ltd (Vico), Beijing (6796),Germany E02 Bentley rest Europe (6E02),Japan E03 Bentley Japan (6E03),Korea, (South) E08 Bentley South Korea (6E08),United Arab Emirates E06 Bentley Middle East and Africa (6E06),United Kingdom E01 Bentley UK (6E01),United States E05 Bentley USA and rest America (6E05)
Brand	Bentley
Transaction No.	2065715/3
Level	EH
Status	Released for publishing
Release date	03-Oct-2023

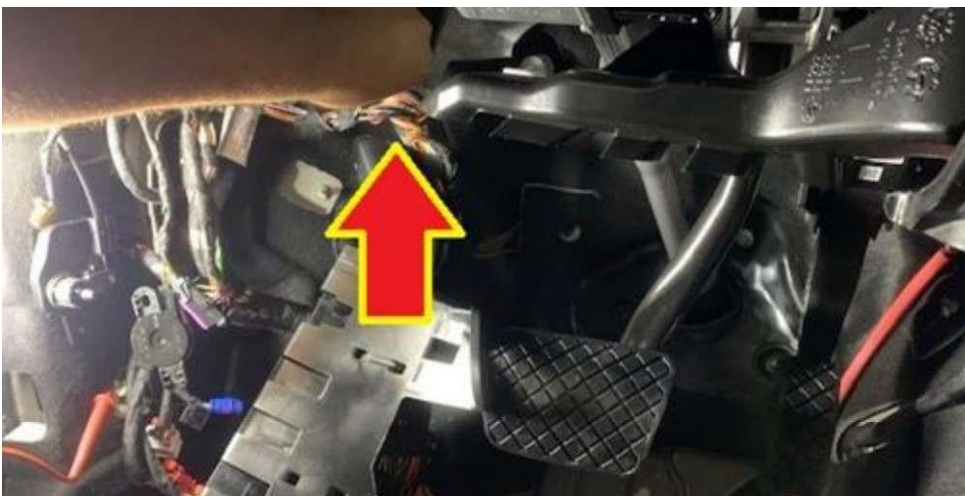
- Referring to the applicable Rep.Gr the operative should gain access to the location shown in Figure 2 (Underside of the dashboard left hand side)

- Check for damaged wiring/contact between the body/surrounding components and the wiring harness

NOTE: Please be aware the wiring harness can contact the body/surrounding components however the actual symptom(s) may be different depending on the wire(s) which are damaged/chaffed

1) Using the applicable wiring diagram, conduct wiring integrity checks to confirm the wire(s) which are damaged/chaffed

2) Referring to Rep.Gr 97 - Repair the damaged wire(s)

3) Remove all sharp edges which could damage the main wiring harness

4) Reposition and secure the main wiring harness
