Technical product information

Topic	Fuel pressure regulator - DTC P242200 with symptom code 14536 evident within address 0001
Market area	Australia E04 Bentley rest Asia and Australia (6E04),China 723 Volkswagen (Anhui) Automotive CO (6723),China 796 VW Import Comp. Ltd (Vico), Beijing (6796),Germany E02 Bentley rest Europe (6E02),Japan E03 Bentley Japan (6E03),Korea, (South) E08 Bentley South Korea (6E08),United Arab Emirates E06 Bentley Middle East and Africa (6E06),United Kingdom E01 Bentley UK (6E01),United States E05 Bentley USA and rest America (6E05)
Brand	Bentley
Transaction No.	2065926/3
Level	EH
Status	Released for publishing
Release date	03-Oct-2023

Bentayga Hybrid

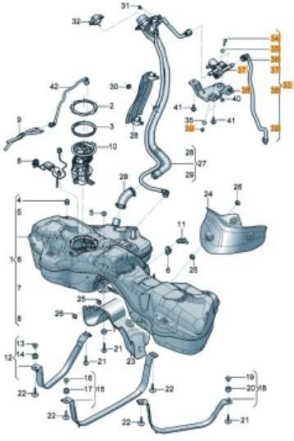
DTC P242200 with Symptom Code 14536 - EVAP System Vent Valve Stuck Closed - DTC evident in Engine Control Module Address 0001

- 1) Referring to Rep.Gr 20 - Replace the Pressure regulator assembly and associated components
- 2) Conduct a road test in EV Mode and/or Hybrid drive mode where possible
- 3) On return from road test - Check to confirm the issue is resolved and DTC P242200 is not evident within address 0001

4M0 201 549A - Pressure regulator assembly and associated parts as shown below
