# Technical product information

<b>Topic</b>	Repeated traction control interventions experienced upon reaching 30km/h
<b>Market area</b>	Australia E04 Bentley rest Asia and Australia (6E04),China 723 Volkswagen (Anhui) Automotive CO (6723),China 796 VW Import Comp. Ltd (Vico), Beijing (6796),Germany E02 Bentley rest Europe (6E02),Japan E03 Bentley Japan (6E03),Korea, (South) E08 Bentley South Korea (6E08),United Arab Emirates E06 Bentley Middle East and Africa (6E06),United Kingdom E01 Bentley UK (6E01),United States E05 Bentley USA and rest America (6E05)
<b>Brand</b>	Bentley
<b>Transaction No.</b>	2067579/3
<b>Level</b>	EH
<b>Status</b>	Released for publishing
<b>Release date</b>	28-Sep-2023

## New Continental GT(C) and New Flying Spur

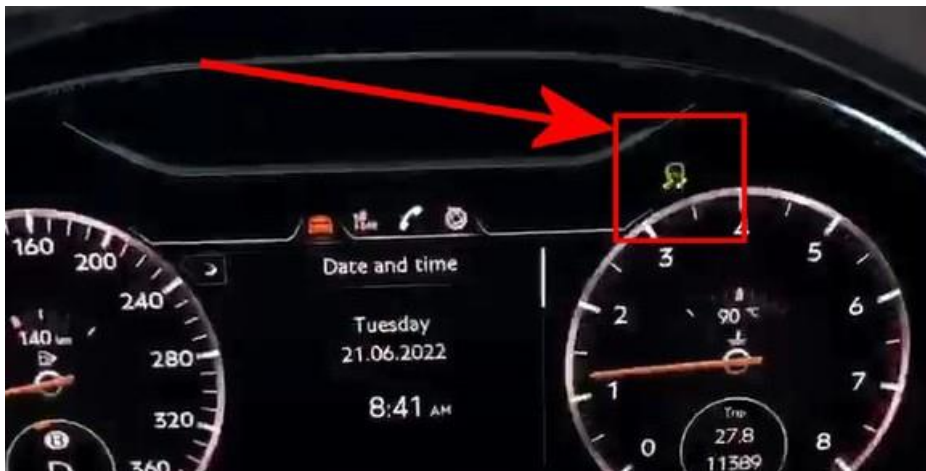
Figure 1

Repeated traction control interventions experienced upon reaching 30km/h (Figure 1)

In the event the issue is as exactly as described, refer to the instructions within the Measure section

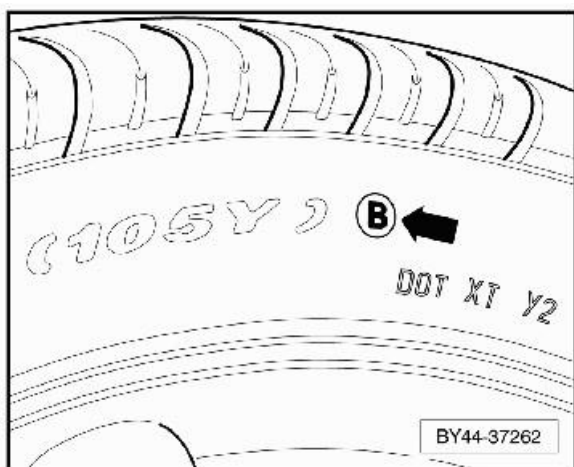
Figure 2

- Confirm the 'B' marking is evident on all tyres (Figure 2)

1) Confirm the tyre pressures (all tyres) are to Bentley specification

- Check to confirm the wheel and tyres assemblies are Bentley approved (same specification parts as per the original factory build
