Technical product information

Topic	V8 Kovomo - Engine misfires - Engine management light illuminated within the DIP
Market area	Russische Föderation (5RU),Australia E04 Bentley rest Asia and Australia (6E04),China 796 VW Import Comp. Ltd (Vico), Beijing (6796),Germany E02 Bentley rest Europe (6E02),Japan E03 Bentley Japan (6E03),Korea, (South) E08 Bentley South Korea (6E08),United Arab Emirates E06 Bentley Middle East and Africa (6E06),United Kingdom E01 Bentley UK (6E01),United States E05 Bentley USA and rest America (6E05)
Brand	Bentley
Transaction No.	2071668/1
Level	EH
Status	Released for publishing
Release date	28-Sep-2023

V8 Kovomo engine

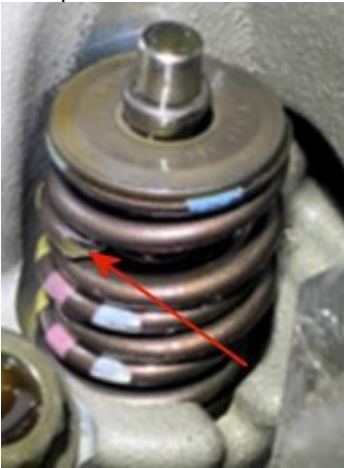
VERY IMPORTANT: Ensure the photos show the location in which the valve spring is broken (ARROW) the various paint markings should also

be captured

- Referring to Figure 1 - Take clear photos of the broken valve spring (from the affected cylinder head only)
