Technical product information

Topic	Bentayga V8 Kovomo - Engine MIL light on - DTC "O2 Sensor Signals Swapped Bank 1 Sensor 2/ Bank 2 Sensor 2
Market area	China 723 Volkswagen (Anhui) Automotive CO (6723),China 796 VW Import Comp. Ltd (Vico), Beijing (6796),Korea, (South) E08 Bentley South Korea (6E08),United States E05 Bentley USA and rest America (6E05)
Brand	Bentley
Transaction No.	2065664/3
Level	EH
Status	Released for publishing
Release date	28-Sep-2023

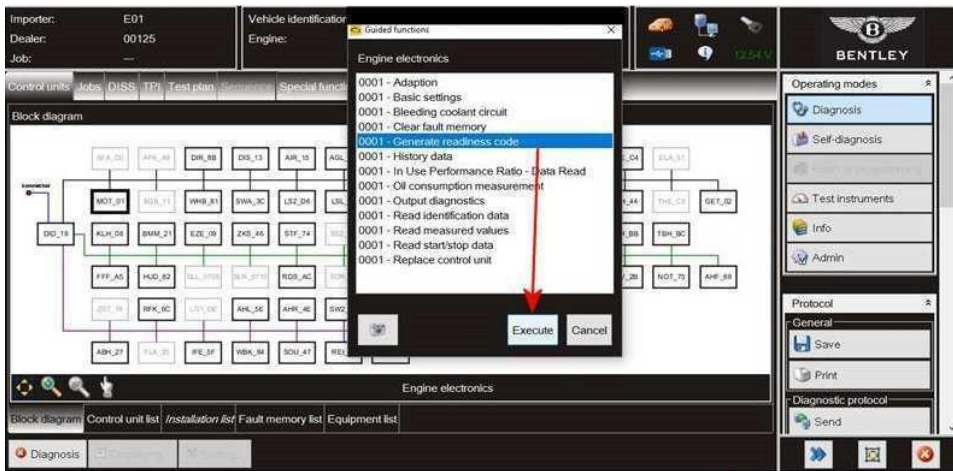
DTC P004100: "O2 Sensor Signals Swapped Bank 1 Sensor 2/ Bank 2 Sensor 2 is evident within address 0001 (Engine control unit) and MIL light active after attempting to conduct a readiness test

- Referring to Figure 1 - Select Guided functions from 01 - Engine Control Module 1
- Select Generate readiness code
- Select Execute and follow the readiness code procedure to completion as per all on screen prompts
