Technical product information

Topic	Rotating display/screen noise - Diagnosis for complaints relating to noise during operation and/or during a drive cycle
Market area	Australia E04 Bentley rest Asia and Australia (6E04),China 723 Volkswagen (Anhui) Automotive CO (6723),China 796 VW Import Comp. Ltd (Vico), Beijing (6796),Germany E02 Bentley rest Europe (6E02),Japan E03 Bentley Japan (6E03),Korea, (South) E08 Bentley South Korea (6E08),United Arab Emirates E06 Bentley Middle East and Africa (6E06),United Kingdom E01 Bentley UK (6E01),United States E05 Bentley USA and rest America (6E05)
Brand	Bentley
Transaction No.	2065895/4
Level	EH
Status	Approval
Release date

New Continental GT

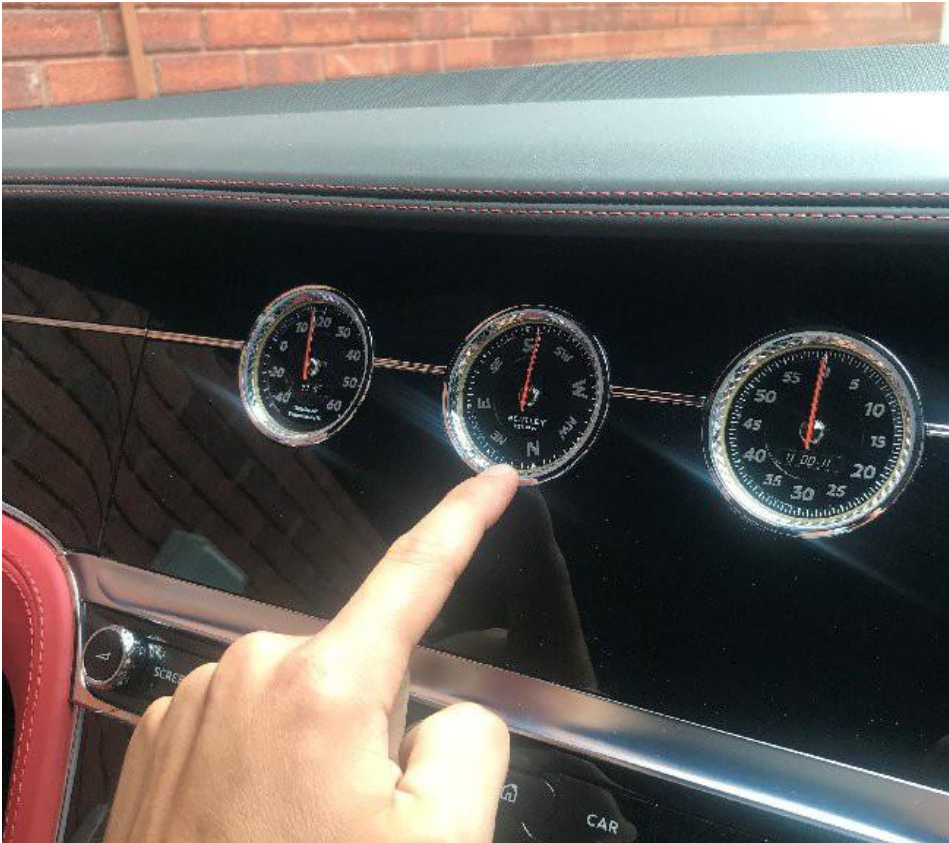
Figure 1

Scenario 1 - Squeak/creak/rattle from the dials during operation or graunching noise from the compass when the vehicle is being driven

When noise is evident from the dials, press on outer bezels (Figure 1) If the noise disappears when the bezels of the dials are pressed - Referring to Gr.91 - Replace the applicable dial(s)

In the event a graunching noise is evident from the compass when the vehicle is being driven - Referring to Gr.91 - Rotating display screen - to remove and fit - Replace the compass

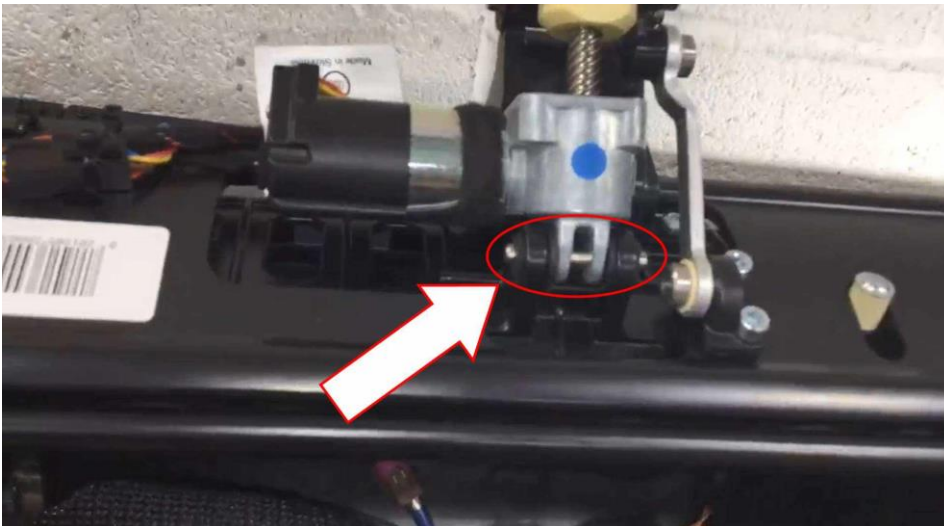
Figure 2

Scenario 2 - Creak/rattle from rotating display whilst driving

TIP: This symptom can in some cases be evident due to excessive movement within the rotating display motor pivot assembly (Figure 2)

NOTE: To check the motor pivot assembly for excessive movement the rotating display should be removed - Refer to Rep.Gr 91

- Refer to the Bentley Hub and refer to the video referencing TPI 2065895/-
- Should the movement be as shown in the video, the rotating display unit should be replaced
