Technical product information

Topic	New Continental GT and GTC - Window drop glass operation
Market area	Australia E04 Bentley rest Asia and Australia (6E04),China 723 Volkswagen (Anhui) Automotive CO (6723),China 796 VW Import Comp. Ltd (Vico), Beijing (6796),Germany E02 Bentley rest Europe (6E02),Japan E03 Bentley Japan (6E03),Korea, (South) E08 Bentley South Korea (6E08),United Arab Emirates E06 Bentley Middle East and Africa (6E06),United Kingdom E01 Bentley UK (6E01),United States E05 Bentley USA and rest America (6E05)
Brand	Bentley
Transaction No.	2070497/5
Level	EH
Status	Approval
Release date

New Continental GT and GTC

Retailer glass reset procedure for GT/GTC

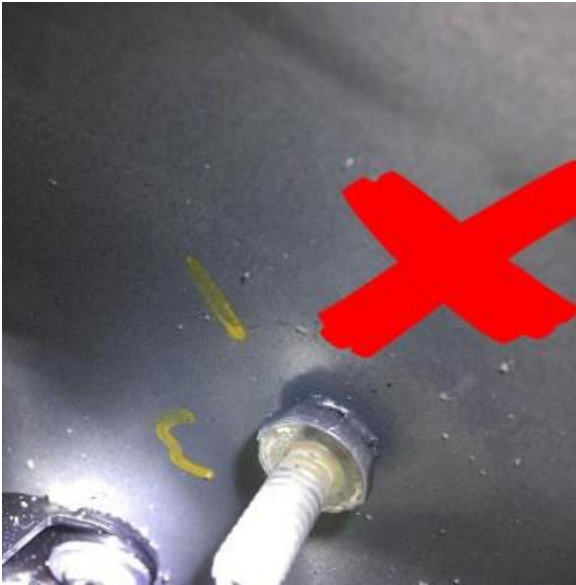
- 12) Check for cleanliness and security of both earth points
- Earth point 736 RHR and Earth point 738 LHR
 - Check for cleanliness and security of both earth points Figure 7 shows an example of a contaminated earth point (dirt/paint/debris)

- Remove any dirt/paint/debris from the earth points using suitable abrasives/wire brush ensuring no damage is caused to the earth stud threads as shown in Figure 8

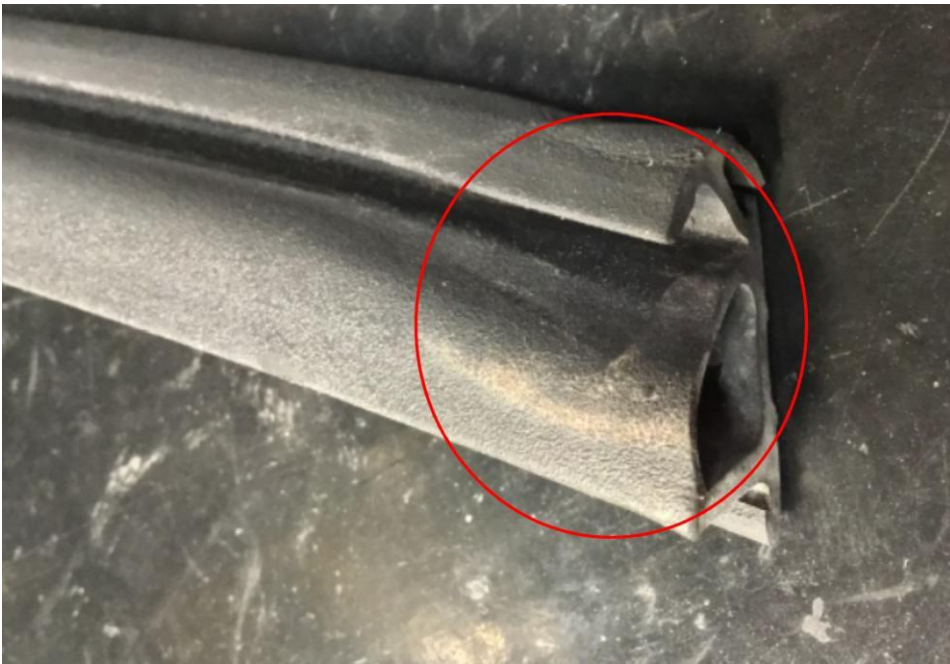
Figure 9

- Secure the earth point fixings (9 Nm)
- 13) Conduct a thorough check of all Window/door seals for the following:
- Damage
 - Splits
 - Tears
 - Misalignment
 - Incorrectly fitted/located
 - Drop glass seal deformation (see Figures 9 and 10 as examples)

NOTE: Any issues found with the window seals must be rectified before conducting the remaining steps

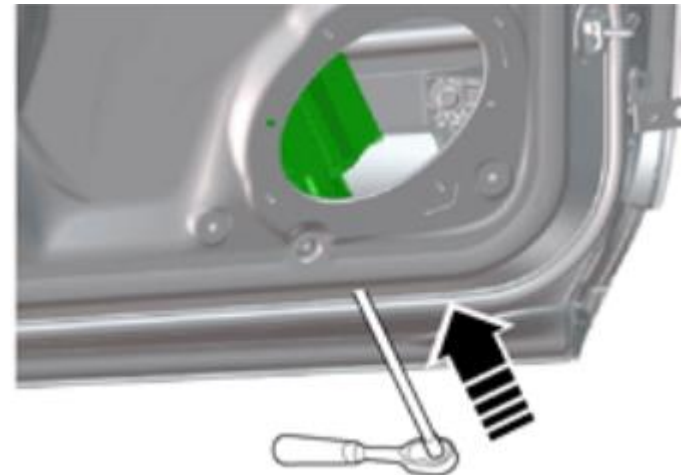
Example: Front drop glass Z axis not adjusted correctly. Bottom of tape was level with waist rail seal, after slackening pinch bolt (3 in bottom left image) front drop glass lowered 14mm to where pen marked line is.

Z-axis adjusters (bottom middle and right images) had not been used, pinch bolt had been slacked and glass lifted out of the regulator to achieve specification. This has a knock on effect of altering the 10mm division bar intrusion seen in previous slide as glass is loose and can be accidentally moved in X-axis.

This also creates a risk that the window will bottom out on the cant rail seals rather than the regulator bump stops meaning that the glass can raise further as the seals soften over time and affect end stop learning.

Z-Axis height should only be adjusted by the 4mm Allen key adjusters as per ELSAPRO
