Macan III – Check engine light with DME fault code P05A(0/3)00

Models	Model Year	Model Type	VIN Range	Vehicle-Specific Equipment
Macan	2022 - 2023	95B	n/a	n/a

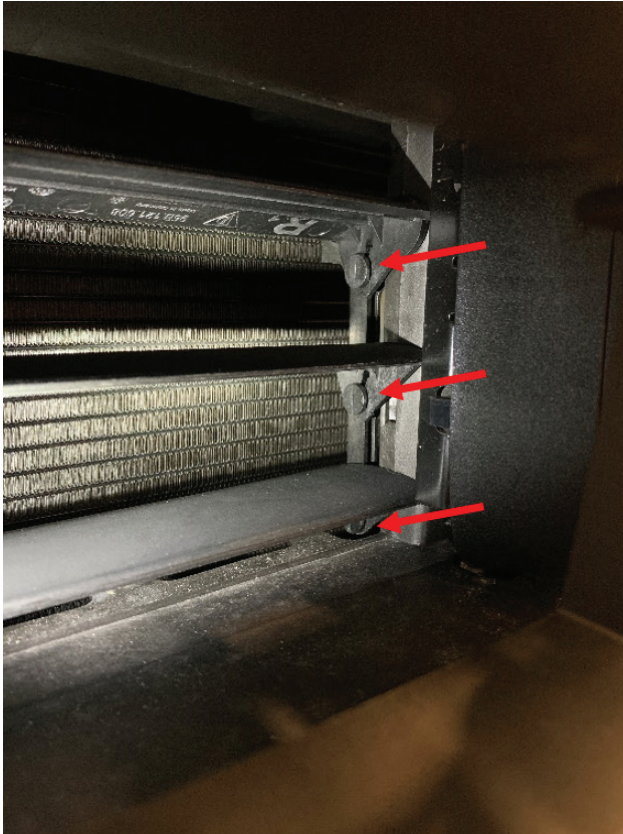
It is possible for excess dirt or ice to mechanically block the radiator shutters or the radiator shutter motor.

1. Check for dirt or contamination at the friction points or the bearings for the motor and clean as needed.
