McLaren Artura – Door Stone Protection Enhancement

Bulletin type:	Service Campaign
Reference number:	N/A
Campaign reference:	SCB 16 A 001
Attention:	Retailer Aftersales Managers, Retailer Service Managers, Retailer Service Advisors, Retailer Technicians, Retailer Parts Managers
Affected vehicles:	McLaren Artura
Situation:	Enhancement of door stone protection with installation of protective gurneys
Procedure:	Action all affected vehicles. Please refer to the information outlined in this document to complete the required work
Date:	10 October 2023

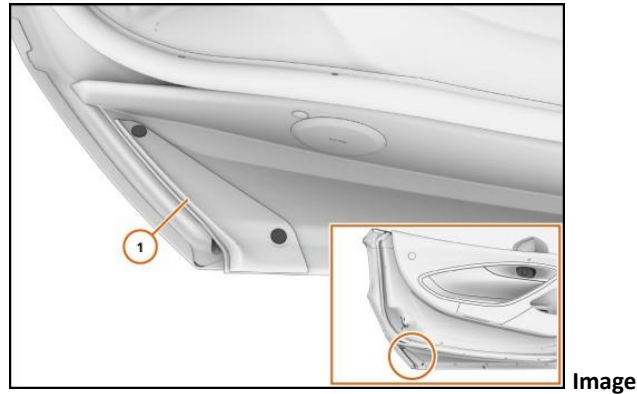
Through continuous product quality monitoring, it has been identified that due to the open duct concept of the door, debris can accumulate around the High Temperature Radiator (HTR) bezel and come into contact with the lower edge of the door causing paint abrasion. To rectify this, McLaren Automotive has released a new protective trim addition (gurney) which should be added at the lower inside edge of both doors.

1 Location of door gurney installation (1)

To perform the required work, follow SIS instruction 'HA-RM-03A052-08-010 – Remove Install Stone protection gurney'. This contains the relevant work instructions and care points to ensure the required work is carried out to bring the vehicle up to current manufacturing standard.
