# McLaren Artura - Flywheel Ring Gear Retention Enhancement

<b>Bulletin type:</b>	Service Campaign
<b>Reference number:</b>	N/A
<b>Campaign reference:</b>	SCB 16 F 001
<b>Attention:</b>	Retailer Aftersales Managers, Retailer Service Managers, Retailer Service Advisors, Retailer Technicians, Retailer Parts Managers
<b>Affected vehicles:</b>	McLaren Artura
<b>Situation:</b>	Addition of Loctite 262 to the flywheel ring gear fixing bolts
<b>Procedure:</b>	Action affected vehicles during next annual service visit. Please refer to the information outlined in this document to complete the required work
<b>Date:</b>	10 October 2023

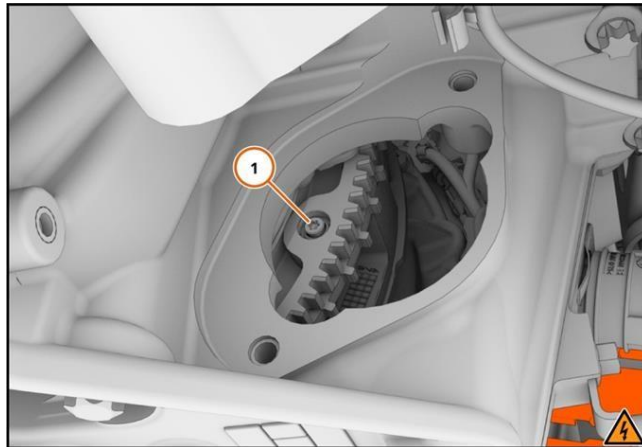
Through continuous product quality monitoring, McLaren Automotive has released an improved fixing procedure for the flywheel ring gear bolts which now includes the addition of Loctite. A rework procedure is outlined in this document. McLaren Automotive requests Retailers to carry out this rework during the next annual service visit of the vehicles affected by this campaign.

**Image 1** Location of flywheel ring gear bolts (1)

To complete this rework, Loctite 262 which can be sourced locally, is required.

The flywheel ring gear bolts should be reused.
