McLaren Artura – Starter Motor Cable Inspection and Rework

Bulletin type:	Service Information
Reference number:	AFT.038.2023
Campaign reference:	N/A
Attention:	Retailer Aftersales Managers, Retailer Service Managers, Retailer Service Advisors, Retailer Technicians, Retailer Parts Managers
Affected vehicles:	McLaren Artura
Situation:	Inspection of the starter motor cable for correct routing and retention
Procedure:	Inspect all stock vehicles and vehicles prior to handover presently at the Retailer
Date:	13 October 2023

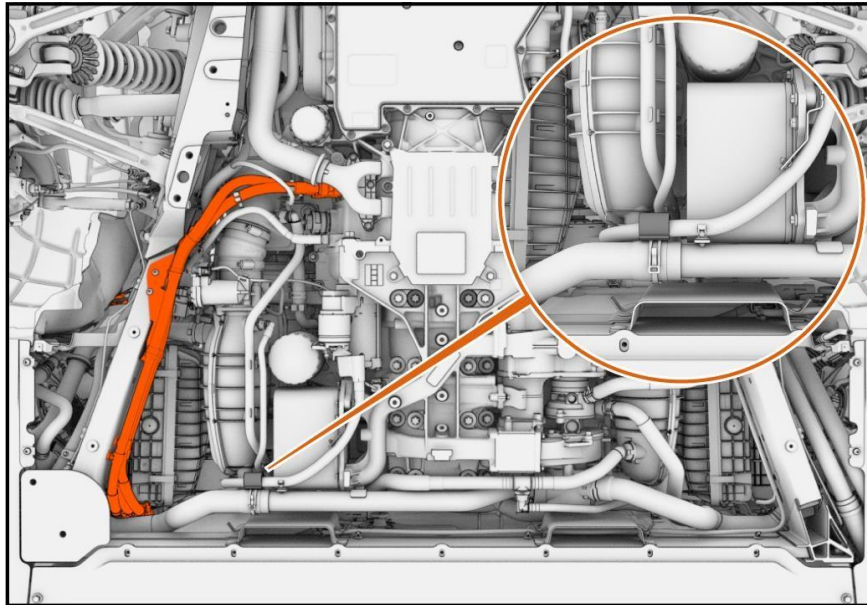
Through continuous product quality monitoring, McLaren Automotive requests all Retailers to immediately commence inspecting the routing and retention and clearance of the starter motor cable from neighbouring components. This inspection must be carried out on any McLaren Artura currently in Retailer stock or with an active Workshop visit.

Image 1 Location of the starter motor cable

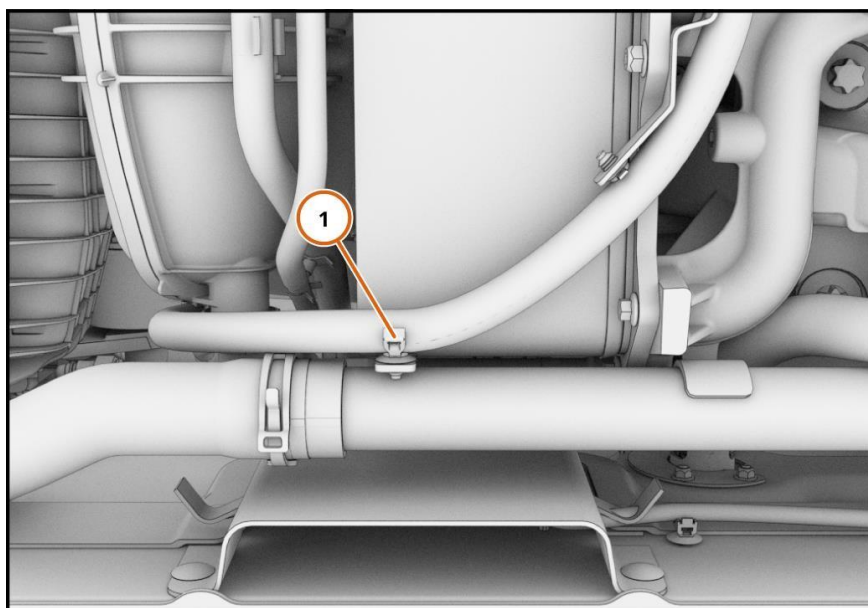
Inspect the fir tree (1) and carry out a pull test.

If the fir tree is fully engaged in the anchor point, holding retention and is not damaged in any way, then no further action is required.

Image 2 Location of fir tree (1)

If the fir tree (1) is not holding retention or is damaged, cut it with suitable side cutter pliers and fit a new fir tree 00RL001 in the same position (1).

Repeat the pull test after fitment of the new fir tree to confirm it stays fully inserted and secure.

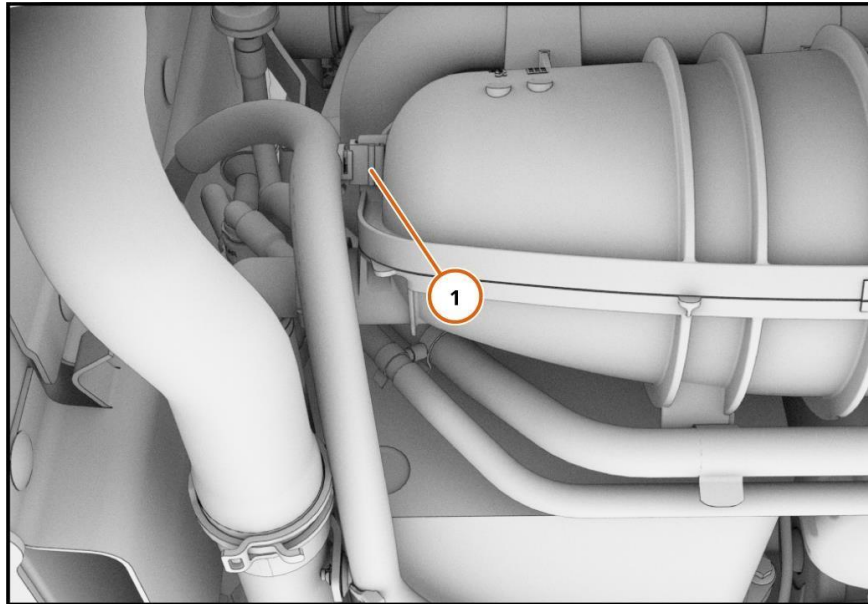
Inspect the edge cable tie clip (1) retaining the starter motor cable to the air intake manifold shown in the image below.

Image 3 Location of edge cable tie clip (1)

If the edge clip is not holding retention or damaged, cut it with suitable side cutter pliers and fit a new edge cable tie clip 00RL022 in the same position (1).

Repeat the pull test after fitment of new edge clip to confirm it stays engaged securely.

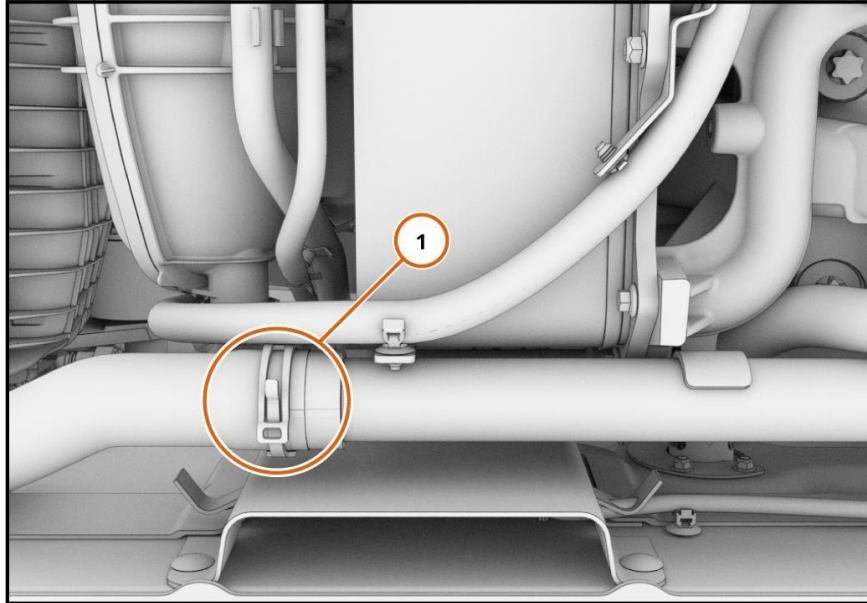
Care Point: The coolant pipe spring clip must be orientated with the tabs/tangs/arms facing downwards with sufficient clearance to the coolant pipe.

Image 4 Location of coolant pipe spring clip (1). Tangs facing down towards the ground.
View from underneath, looking upwards.

If the coolant pipe spring clip requires adjustment, use appropriate tool to slightly loosen it and rotate it so that the two tangs of the clip are facing down towards the ground and away from the starter motor cable.

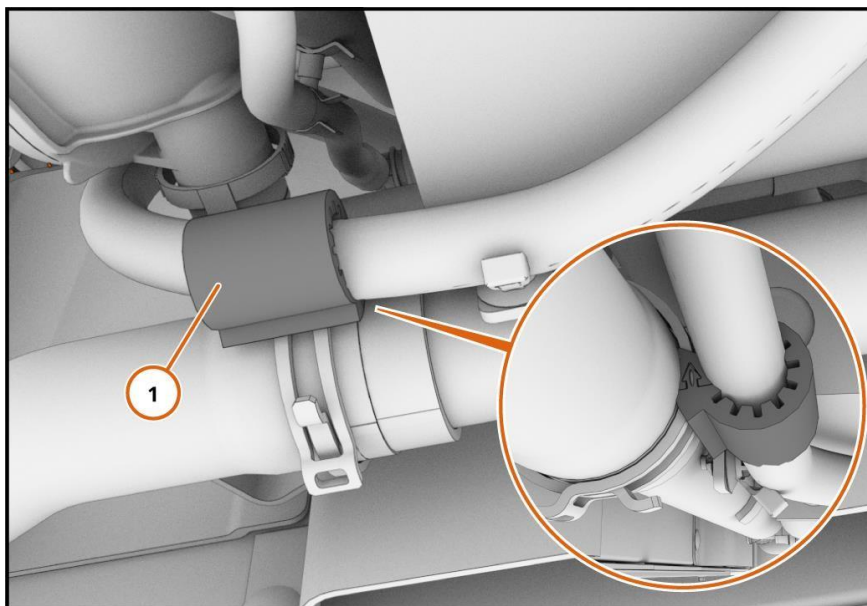
CARE POINT: The new protective rubber sleeve is used to create a mechanical clearance gap between the metal spring band clip on the cooling pipe and the starter motor cable.

Image 5 Location and orientation of protective rubber sleeve (1) fitment.

Fit the new protective rubber sleeve 00RA357 (1) around the starter motor cable in the area shown. The protective rubber sleeve must be fitted in the same orientation as shown below (thicker side facing towards the coolant pipe) and be fully secure.
