Model: Moto Guzzi V100 Mandello - Mandello S

Subject: Troubleshooting guide

TROUBLESHOOTING GUIDE

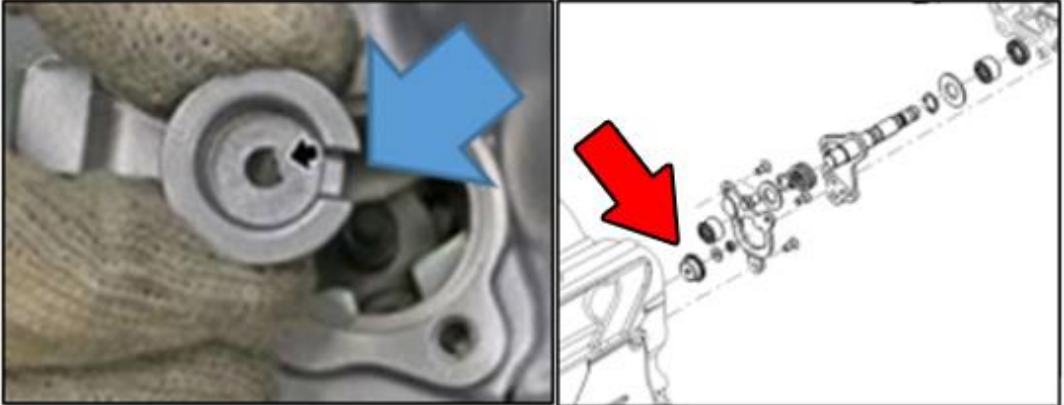
| Fault | Incorrect gear number display on instrument panel. |
| Possible causes | Gear selector malfunction. |

| Solution | <p>Replace the part no. 1A020942 with part no. 2A0015145 updated in dimensional tolerances → Display fault resolved.</p> <p>N.B. Replacement of the gear sensor part no. 1A018096R is not necessary.</p> |

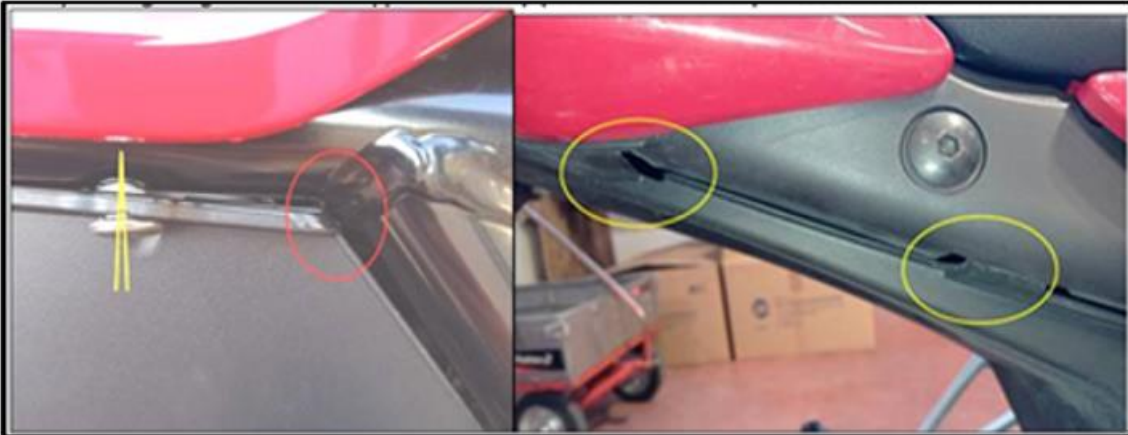
Test 1: Undertray checks

| Test | <p>Check the fastening of the undertray. Ensure the undertray is correctly seated and un-stressed on the frame.</p> |

| A | The undertray is loose → Fix the undertray (RESOLVED) |
| B | The undertray preloads the frame → Eliminate the preload (RESOLVED) |

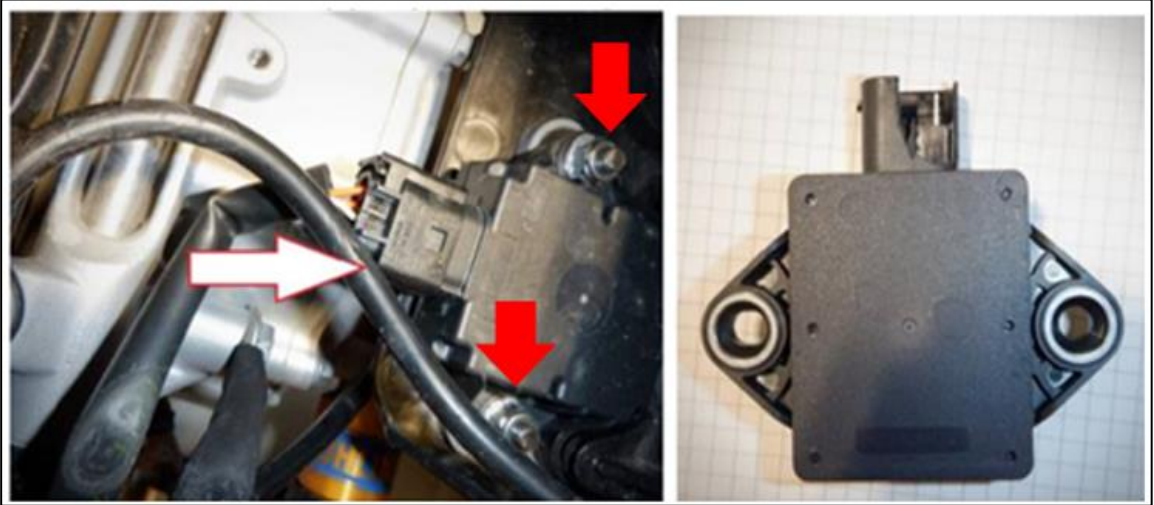
Check for cables or wiring harness that stress the inertial sensor body or connector.

| B | Cables or wiring harnesses preload the inertia sensor connector → Eliminate preload (RESOLVED) |

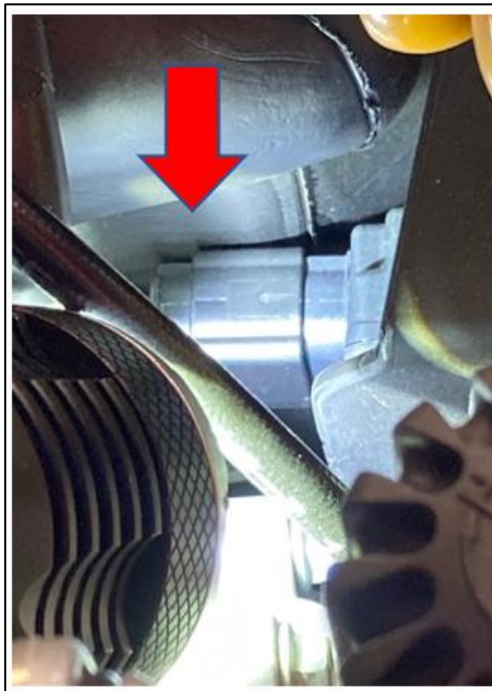
Check whether the petrol tank stresses the inertial sensor connector.

| C | The petrol tank preloads the inertia sensor connector → Replace the petrol tank (RESOLVED) |

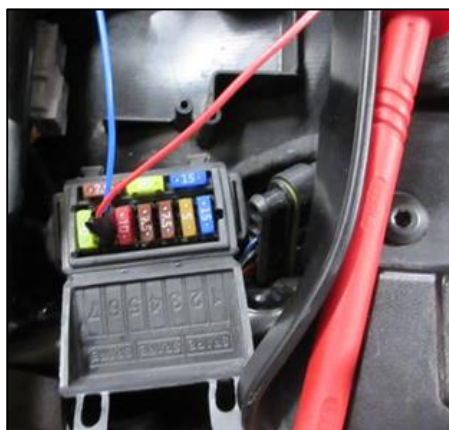
Remove the 5A fuse (instrument panel supply line) and connect a current tester with a scale of 400/500 mA.

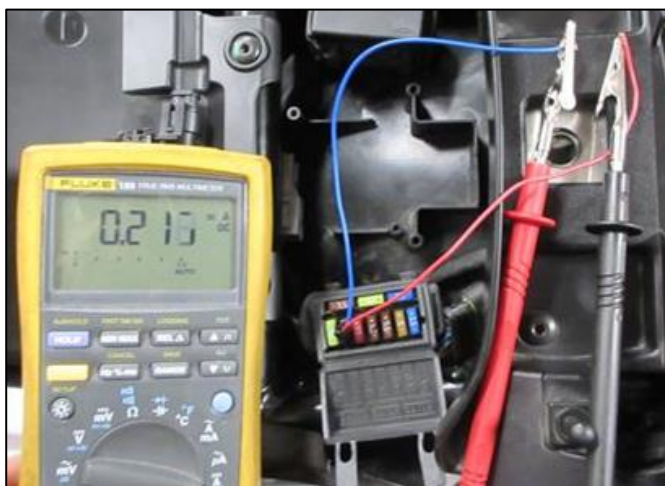
The value shown by the instrument after a few seconds will be the current absorption of the instrument (in the example photo below, the current absorption is 0,215 mA, regular instrument panel absorption).

Normal absorption: 0.2 - 5 mA → **Replace the battery only if the correct charging procedure does not restore the battery to 13 volts. (RESOLVED)**
