# **Advanced Technical Information**

Bulletin #: 2321.1

## InnoDrive - Active Lane Keep Assist Function Not Available in the Vehicle

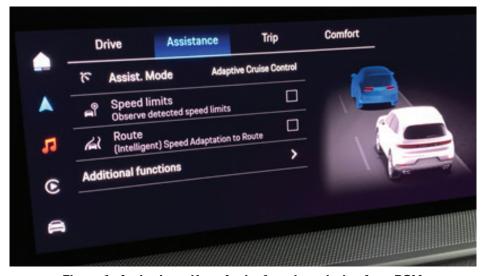
The customer states that the Active Lane Keep Assist function is not present in the PCM, despite the vehicle being equipped with InnoDrive.

Figure 1- Active Lane Keep Assist function missing from PCM

A programming error from production may cause the Active Lane Keep Assist (ALKA) feature of Porsche InnoDrive to not be activated in the adaptive cruise control (ACC) control unit, despite the vehicle being equipped with Porsche InnoDrive.

- 1. Please create a VAL to document the coding information in the ACC control unit. Please also take a picture to document the absence of ALKA in the PCM.
  - => Vehicle menu => Assistance
- 2. Perform Component Protection Commissioning of the ACC control unit:
  - => Overview => Additional menu (F7) => Component protection commissioning => Distance sensor (ACC)

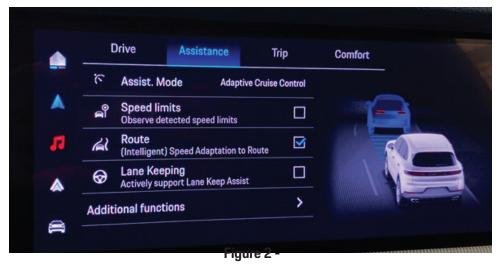
Active Lane Keep Assist available after component protection commissioning

Follow the on-screen prompts to ensure the commissioning completes successfully.

The PCM menu should now show the option for ALKA:
